Report on the Nagoya Works power failure accidents -- The causes and preventive measures --

November 25, 2014
Nippon Steel & Sumitomo Metal Corporation

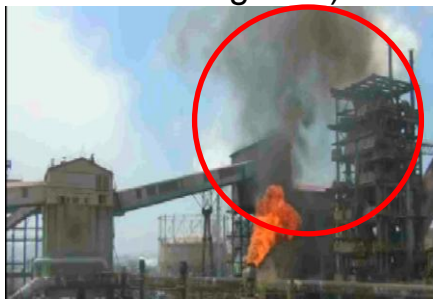
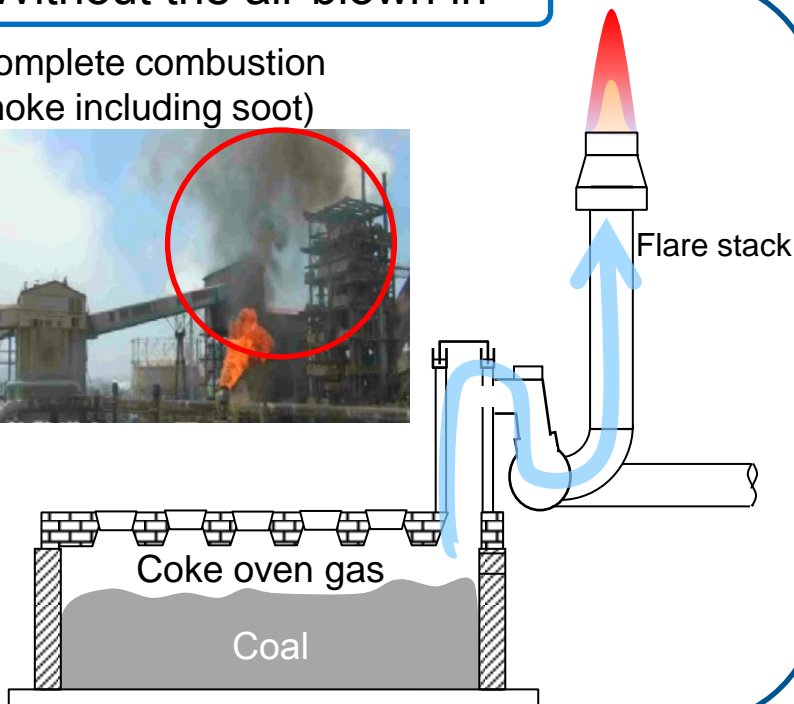
Without the air blown in

By blowing in a massive amount of the air, complete burning of the gas is promoted and smoke generation is significantly reduced. The air needs to be blown into the flare stack with the steam* but when power failure occurred, the steam supply was halted, resulting in incomplete combustion.

Incomplete combustion
(smoke including soot)

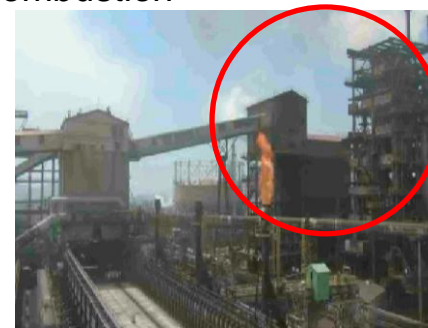
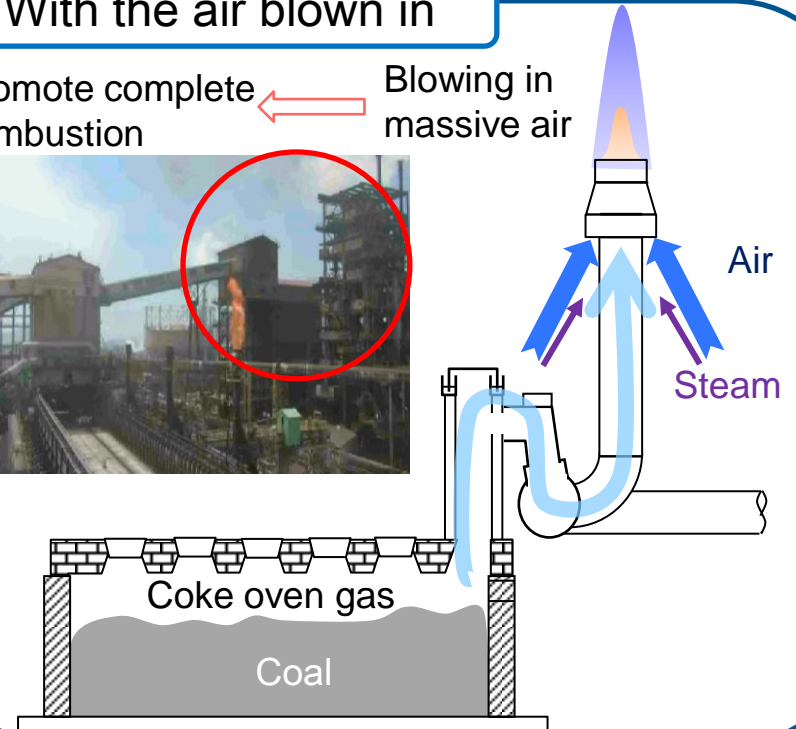
With the air blown in

Promote complete combustion

Blowing in massive air
