Report on the Investigation of the Nagoya Works Coke Fire Accident and Power-Receiving and Distributing Equipment

April 7, 2015
**Nippon Steel & Sumitomo Metal
Corporation**

I. Report on the Coke Fire Accident (Coke Accident Response Committee)

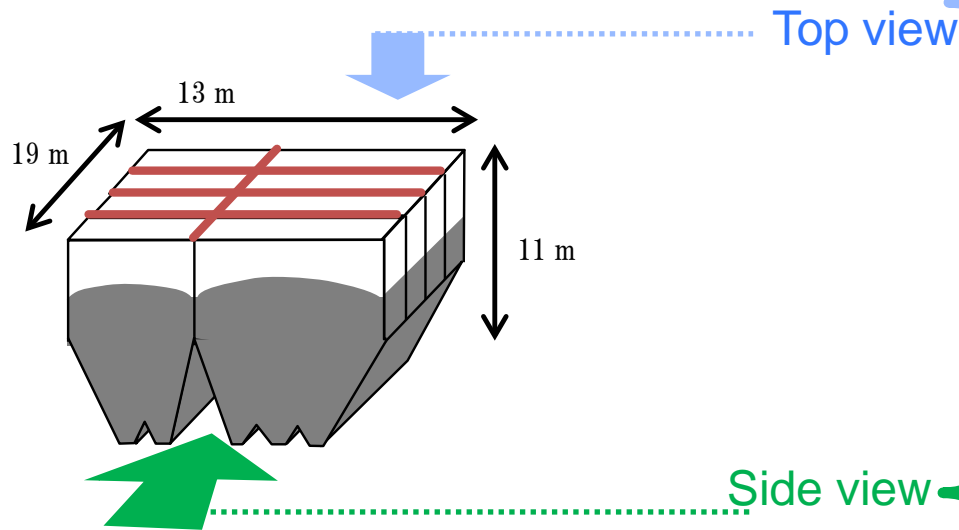
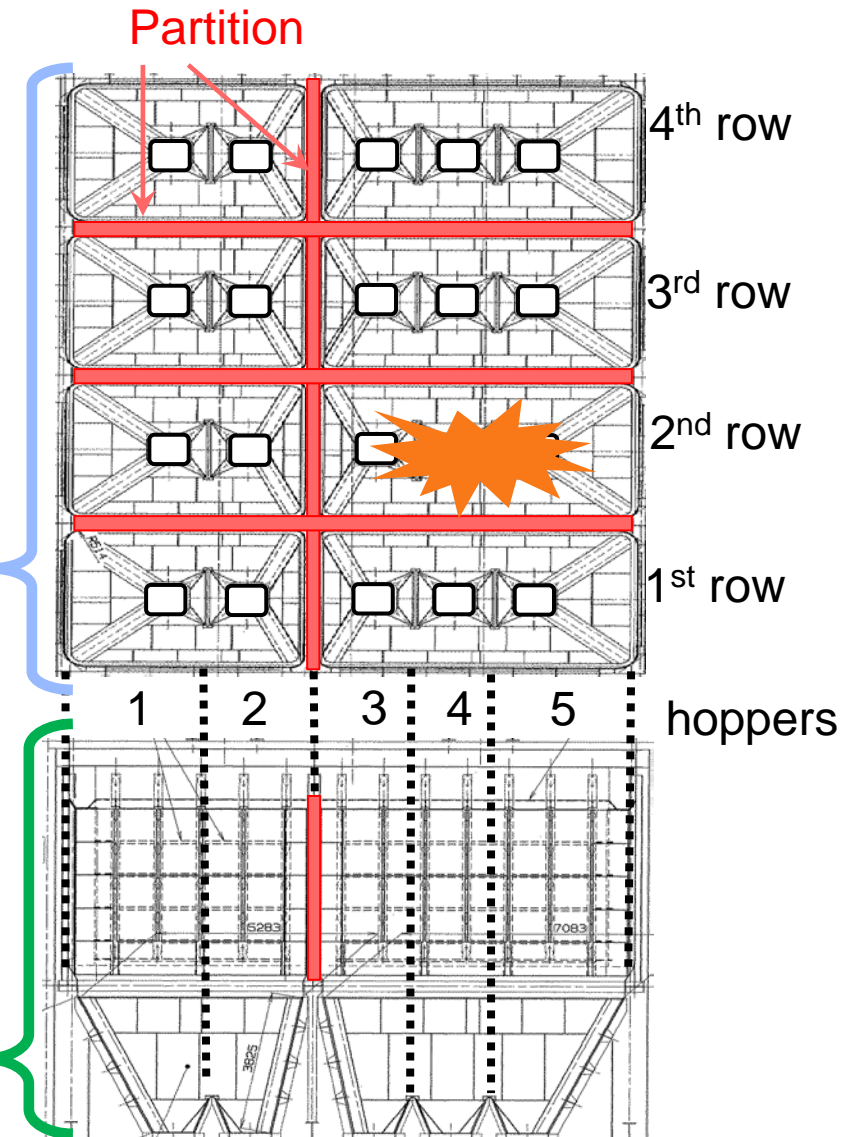
1-(3) Structure of Coal Bin in a Coal Tower

- The coal bin temporarily stores coal to be charged into a coke oven. (When the accident occurred, approx. 100 tons of DAPS coal was stored in the 2nd row of the bin. About 21 tons are discharged per batch.)
- The coal bin is partitioned by walls into rows and hoppers.
- The accident is presumed to have originated in the 3rd, 4th, and 5th hoppers on the 2nd row.

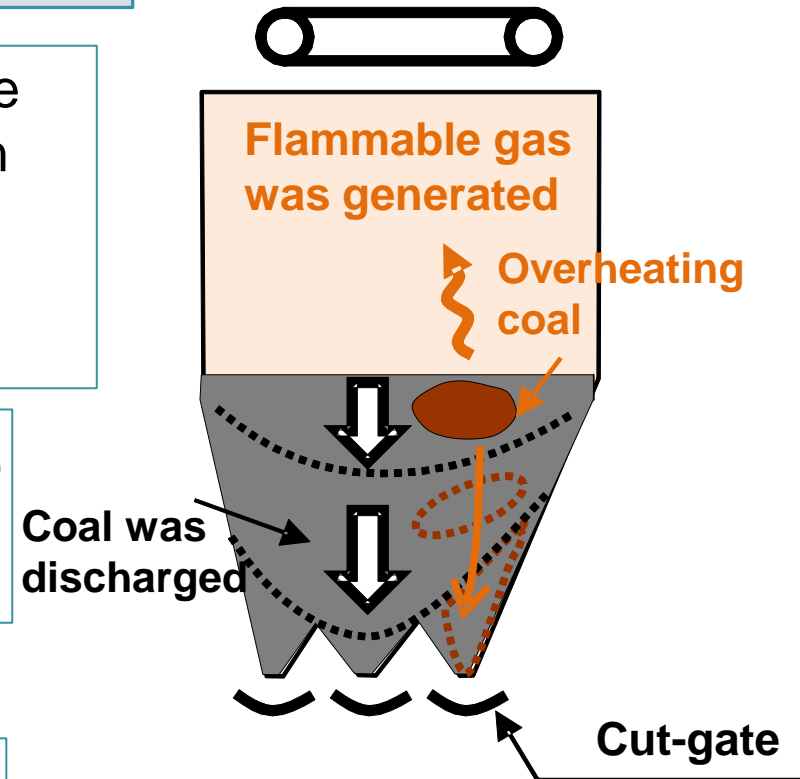
Belt conveyor on top of the bin

(1) Before coal was discharged (before 11:15)

1) DAPS coal was last transported from the DAPS facility on Aug. 30 and was stored in the coal bin for about 4 days. The coal became oxidized and its temperature rose spontaneously.

2) Hot coal, mixed in the bin, promoted spontaneous heating partially.

3) Spontaneous heating of coal generated CO and other flammable gas.

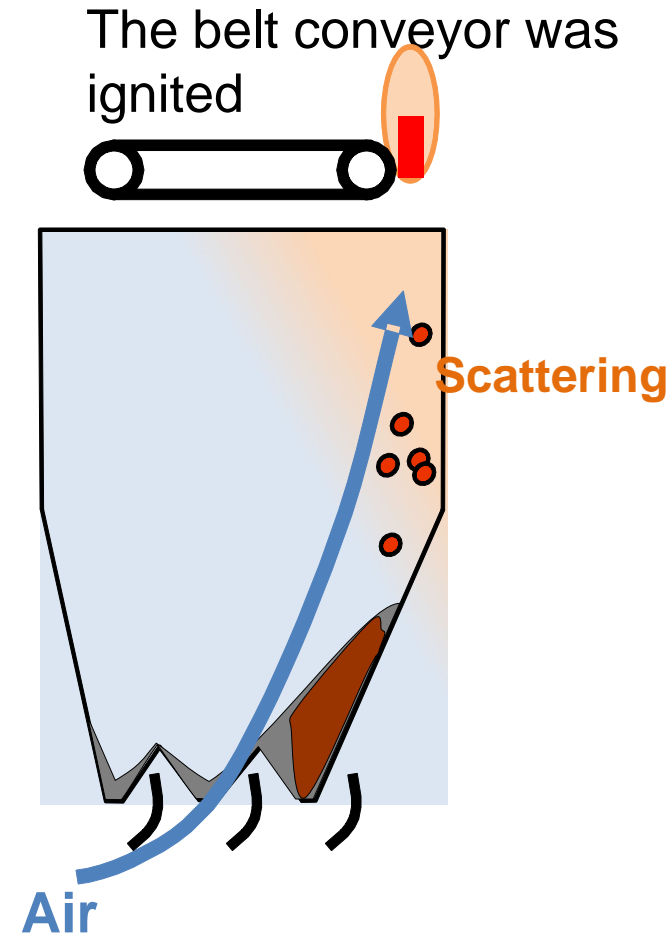
2-(1) How the Fire Accident Occurred-2

(2) The belt conveyor was ignited (at about 12:10)

4) High-level CO in the coal tower prevented direct spraying of water. Coal was then remotely discharged in five times. After the last discharge, overheating coal unintentionally remained in the coal bin. The residual overheating coal and gas were blown up by the air, which was rapidly flowing in from the bottom of the bin*, resulting in igniting the belt conveyor.

* Subsequently, the cut gate was shut down and stopped the entry of air.

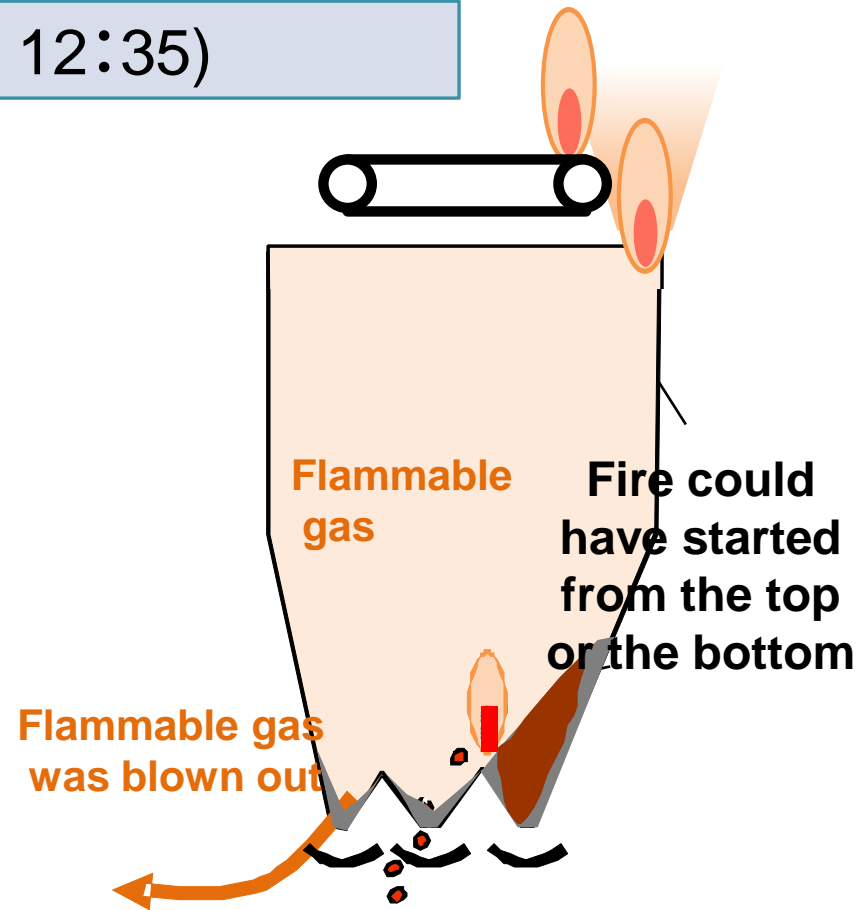
2-(1) How the Fire Accident Occurred-3

(3) The fire accident occurred (at 12:35)

5) The residual overheating coal continued to generate flammable gas mainly consisting of CO, and the fire could have started from the ignited belt conveyor on the top or the overheating coal within the bin.

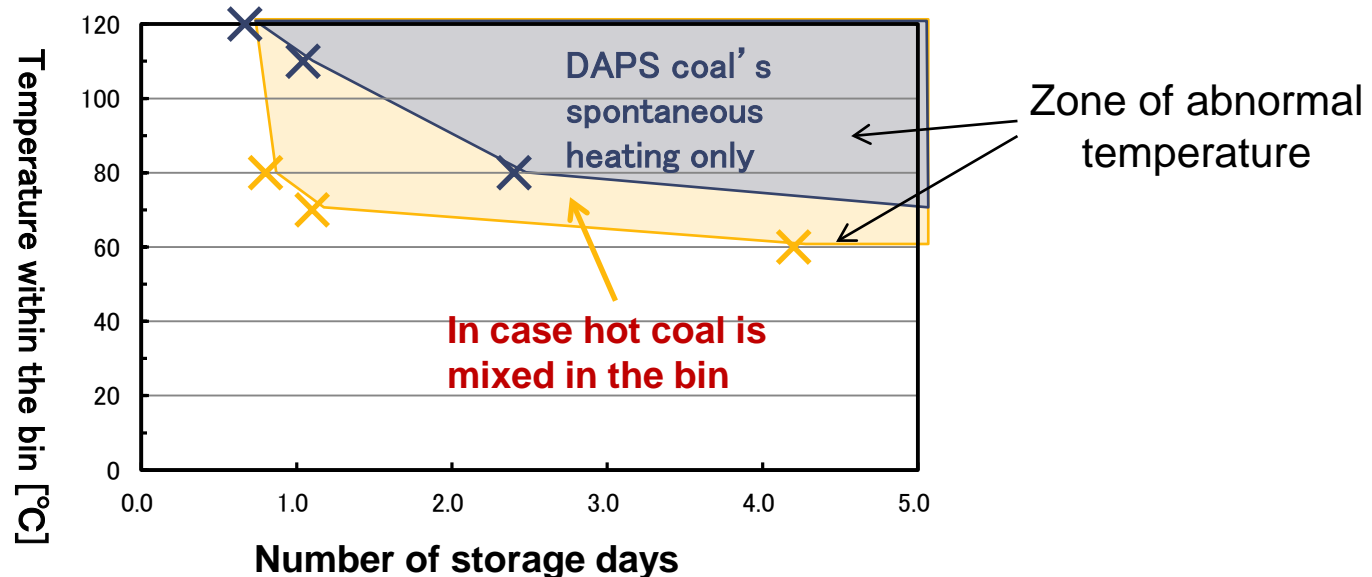
1) Take measures to prevent abnormal rise in coal temperature within the bin

【Action】 Revise the handling standard

- Keep the coal temperature within the bin equal to or less than 60°C. The DAPS coal is all discharged within three days at maximum.
- Any coal with a temperature exceeding 60°C is entirely discharged immediately (within one day).

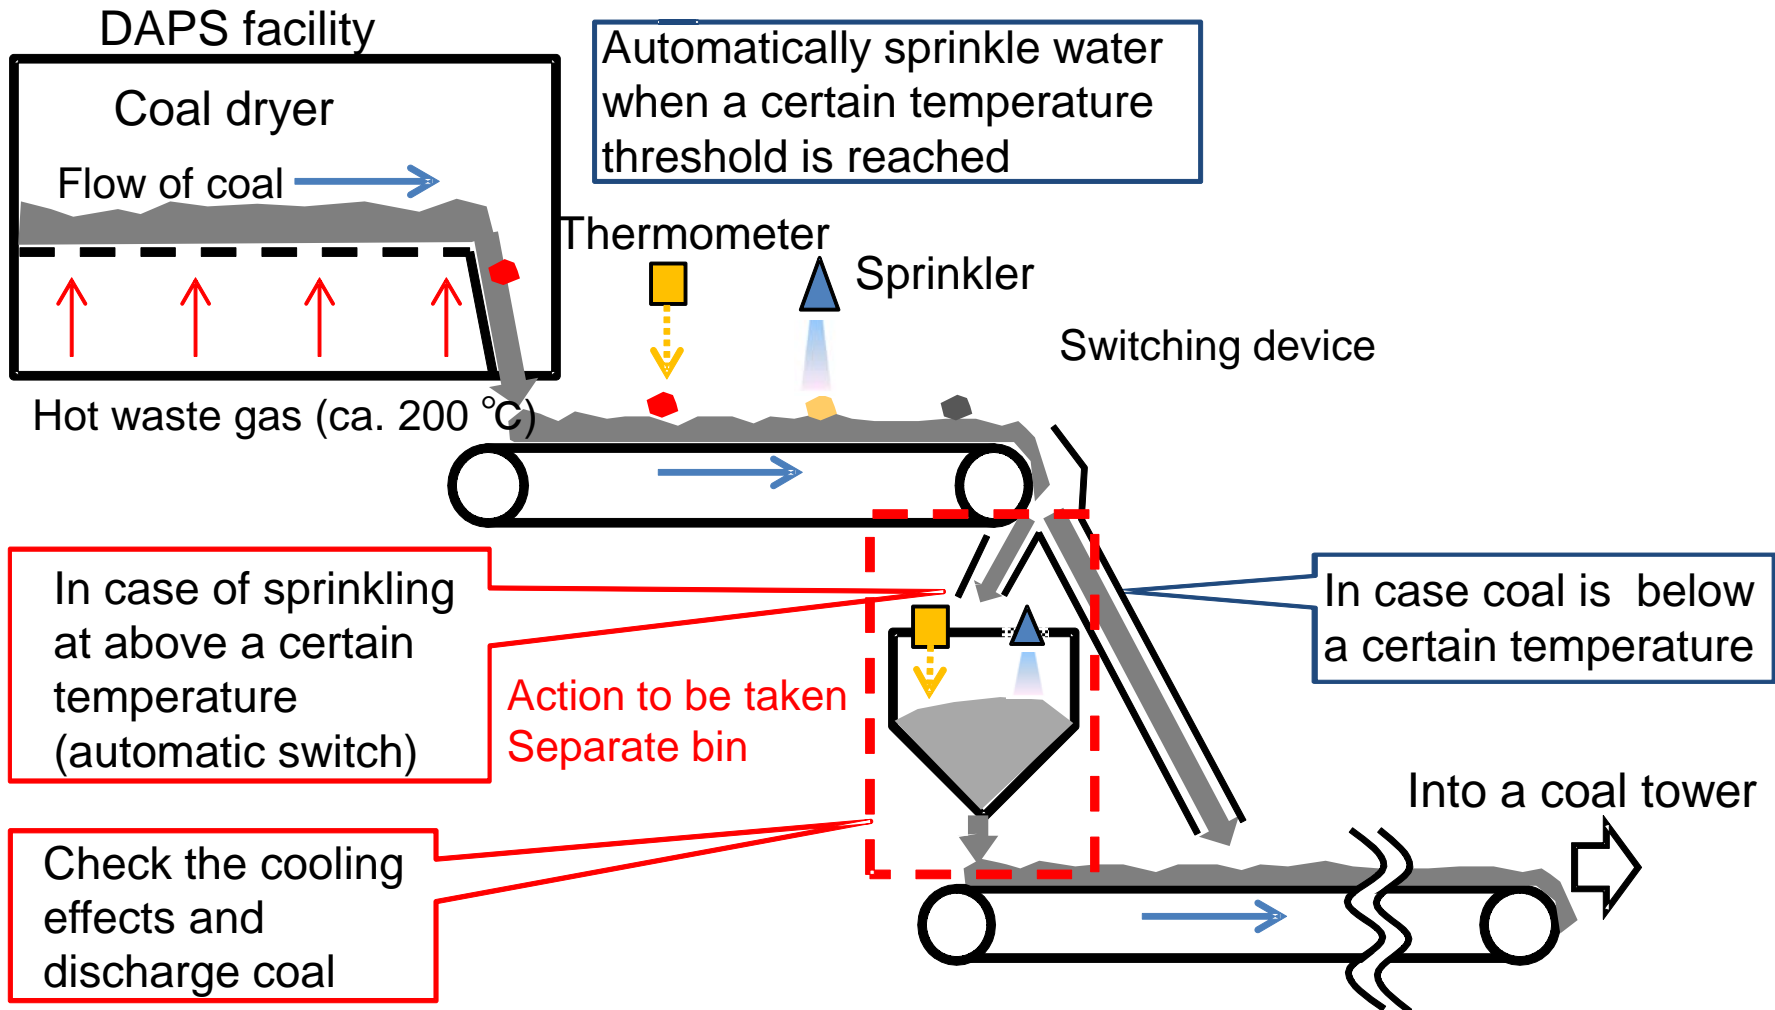
2) Take measures to prevent hot coal from being mixed in the coal bin

【Action】 Improve the function of coal temperature control

- Coal hotter than a certain level is cooled by the (existing) automatic watering equipment and separately stored in a newly installed separate bin.
- A dust collector is installed near the belt conveyor to improve reliability of the thermal sensor.

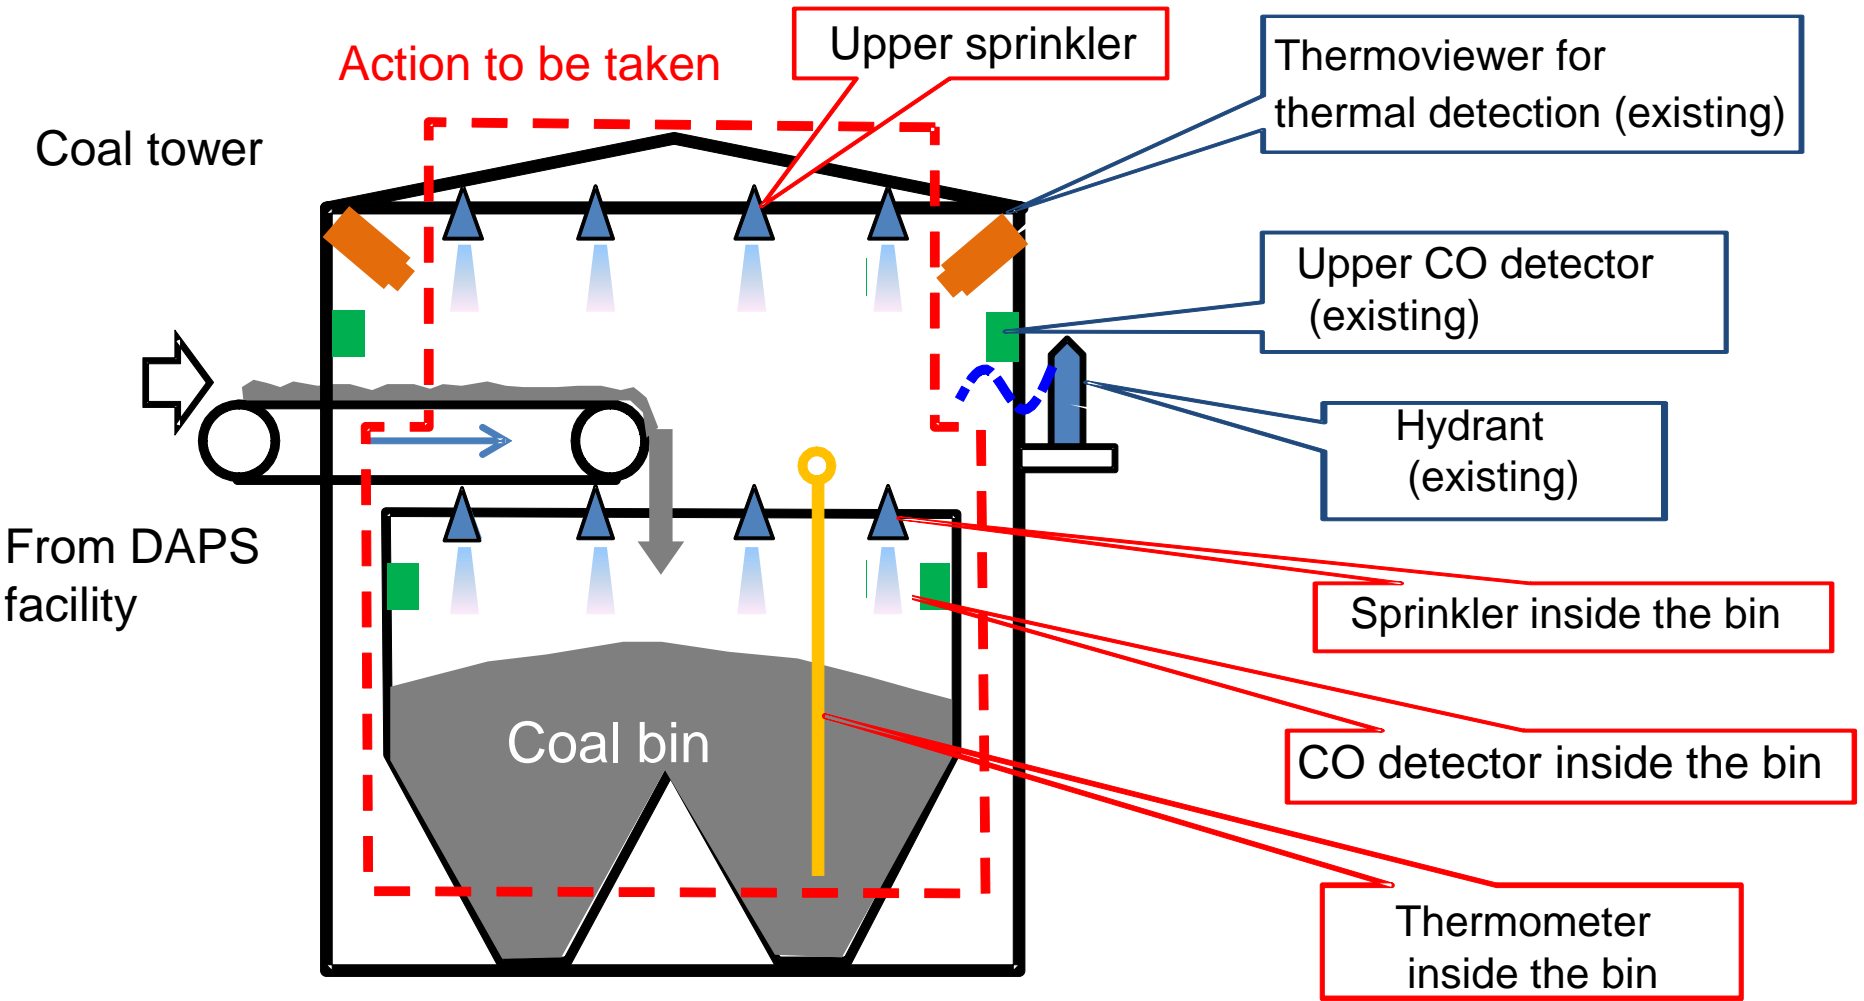
3) Take measures to prevent fire from spreading even when coal within the coal bin becomes overheated

【Action】 Implement fire preventive measures

- Implement measures for early detection of a spontaneous rise in the temperature of coal within a coal bin (by installing CO detectors and thermometers in the coal bin)
- Implement an early-action measure to prevent fire from spreading by early detection (by installing a remote-control sprinkler system within the bin and on the ceiling of the coal tower, equivalent to 600mm of rainfall per hour)
