Damage by East Japan Earthquake and Tsunami in 2011 to Port Facilities and Their Restoration

Abstract

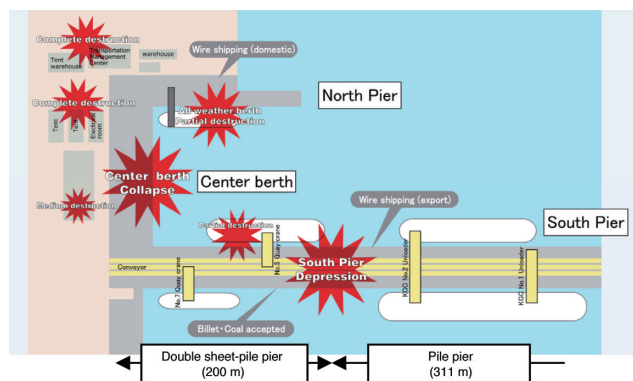
Fig. 1 Damage situation of Kamaishi Works port facilities

The port facilities of Kamaishi Works include the south pier, the north pier (or the all-weather berth) and the center berth. As seen in **Fig. 1**, most of the works' port facilities were heavily damaged: the double sheet-pile walls of the south pier collapsed; the conveyor on it was demolished; the No. 5 crane also on it for unloading billets for wire-rod rolling was partially destroyed; the center berth collapsed;

and the building of the all-weather berth was largely destroyed.

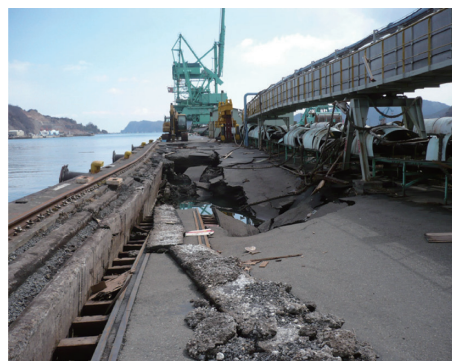
Photo 2 Sunk apron of south pier

Soon after the quake, depressions more than 1 m in depth, like the one shown in Photo 2, were found at different parts of the pier near the end of the double sheet-pile wall portion, 150 to 200 m from the land, and the extent of the damage and distortion of the sheet piles under the water were quickly investigated by a sonar and divers. As a result, the sheet-pile walls were found to bulge beyond the normal limit by more than 3 m, and underwater photographs revealed that many fixing bolts of the lower tie-rods had detached from the sheet piles as seen in Photo 3. In contrast, no serious damage was found in the extended pipe-pile bridge portion beyond 200 m from the land.

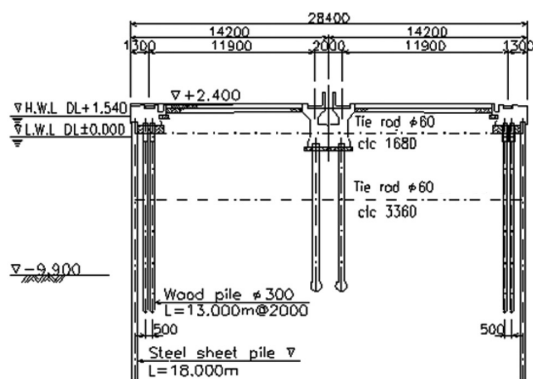
Fig. 2 Section view of south pier

pile wall structure shown in Fig. 2; YSP-V sheet piles were used for the double wall, and pine piles for the crane-rail foundations, which served also as the coping. The extension beyond the 200-m portion, the first 138-m long portion and the second 150-m portion being constructed in 1969 and 1979, respectively, was a pier composed of steel pipe piles. The water depth was 9.5 m along the 200-m double-sheet-pile portion, and 14 m along the entire extended portion to accommodate cape-size bulk carriers of coal.

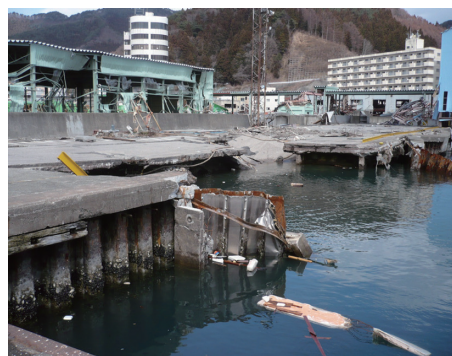
Photo 4 Destroyed center berth

The center berth, which was reconstructed after being damaged by the tsunami of the Chile earthquake in 1960, was of a wall structure of FSP-III sheet-piles, 16.3 m in length each, with bracing tie-rods. As seen in Photo 4, the sheet-pile joints came loose, and many of them fell seawards.

The same recording showed a backrush of the sea so large that the bases of the revetments (−6 to −8 m) in the port area protruded above the water. From this, the backrush was presumed to be one of the causes of the destruction of the sheet-pile walls of the south pier and the center berth, that is, collapsing of the apron and water rise in the backside of the walls due to the high water, subsequent rapid fall of the water level at the wall front and an additional seaward pull at the wall head due to the backrush presumably led to the collapse of the wall.

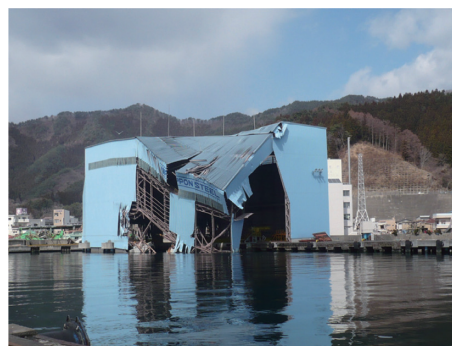
Photo 5 Partially destroyed all-weather berth

The all-weather berth was a steel-frame building for the loading of wire-rod products for domestic clients having a span of 35 m. As seen in Photo 5, the building structure was severely distorted by a large horizontal force from the sea side.

the Port of Kamaishi; one of them taken by the Japan Coast Guard from the building roof of the Kamaishi Port Office clearly recorded the vessel Asian Symphony (5000 DWT) at the time of the earthquake being loosened from the south pier by the tsunami and hitting the all-weather berth several times. The damage of the berth was presumed to have resulted from the collision.

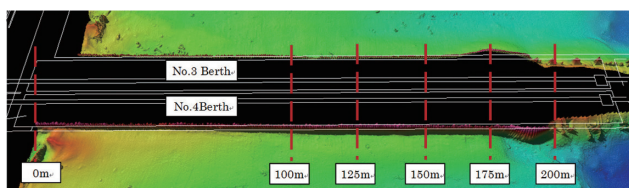
Fig. 3 Findings of underwater sonar at south pier

It was decided from the functional and structural viewpoints that the double sheet-pile walls, which had been heavily damaged, would have to be removed. The results of the sonar examination revealed that the portion up to 125 m from the land was sufficiently sound, but the 75-m portion beyond it (125 to 200 m from the land) was earmarked for dismantling. **Figure 3** shows the investigation results obtained by the underwater sonar. Sheet piles were newly driven at the 125-m point, and to reinforce the interface zone, the sea-floor soil was improved by the high-pressure jet mixing method.

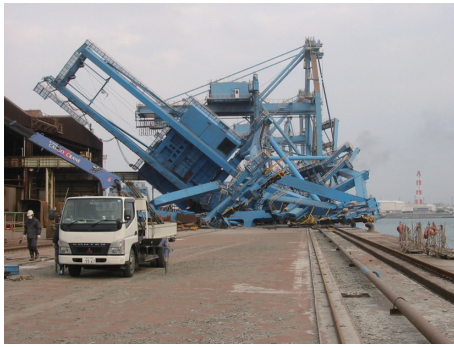
Photo 10 Damage to shipping crane

Figure 7 shows the layout of the entire works, and Table 1 outlines the port facilities and the damage inflicted on them. One of the characteristics of the damage by this earthquake is that, besides the damage to structures by the seismic force, tsunami and ships unleashed by it struck the cranes and other port facilities as in the case of Kamaishi, which added to the purely seismic damage. Figure 8 shows the change in the tide level at a seawater intake of the works; the water sank to as much as 6 m below the datum level (DL) at the lowest. The drifting of many ships by the tsunami was confirmed later with photographs and word of mouth. Photo 10 shows a loading crane for export products that collapsed after being hit by a drifting ship, and Photo 11 shows a damaged quay protection of steel sheet piles due to the ship collision.

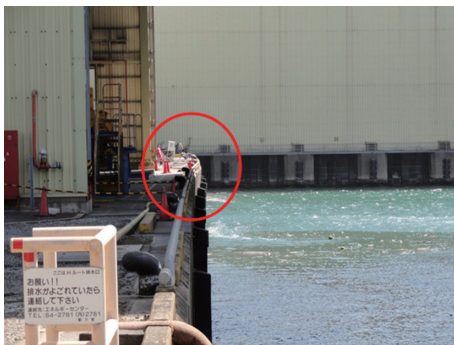
Photo 12 Displacement of the berth line (berth 2)

In contrast, liquefaction and lateral flow of soil occurred in some parts of the backland of the berth for domestic product shipment, and the sheet pile wall partially inclined toward the sea beyond the normal line (see Photo 12). This is presumably because the soil was of comparatively loose sand, the backrush of the tsunami dug into the sea boom in front of the wall, and at the same time, water remaining on the land increased the pressure from behind.

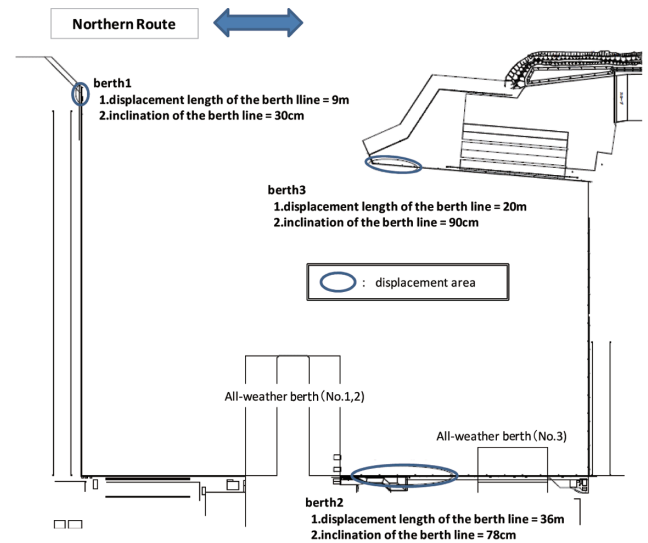
Fig. 9 Damage to product shipping berths

As illustrated in Fig. 9, ships enter the bay of the domestic product shipment berth from the north route of the Port of Kashima. According to the port plan, the quay was to have the tie-rod-and-bracing-plate structure or similar for a water depth of DL-7.5 m to accommodate 4000-DWT vessels. The damage to the quay was as follows: in portions about 65 m in total along the normal limit, the coping distorted and fell projecting toward the sea by 90 cm beyond the normal limit at the largest (see Fig. 9 and Photo 12). As the failure of the tie rods and the dislocation of the bracing plate were suspected to have caused the quay distortion, the bracing structure was investigated by excavation, but no such serious problems were found.
