# Renewal of Pouring Reels of Bar Mill Plant

## Abstract

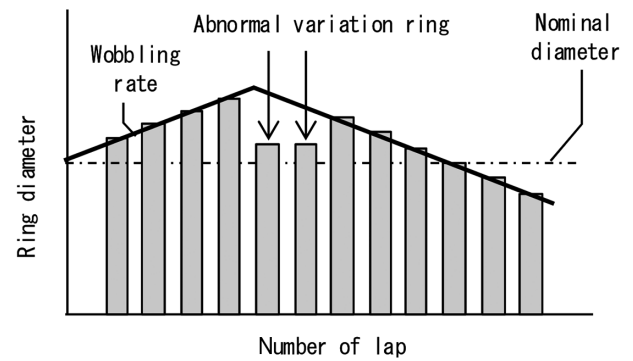
Fig. 4 Measurement results of the ring diameter

Investigations into the cause of banding marks confirmed that they occurred more often at specific positions as explained below. To increase the packing density of coils, the reel rotation speed is changed during the coiling of a bar so as to evenly distribute the rings from the inner to outer sides of the coil; this speed control is called wobbling control (see Fig. 4). When the diameters of the rings in which banding marks occurred were measured, however, more than half of them were found to occur in rings with irregular diameters not conforming to the wobbling control. Figure 4 shows a case where the diameters of some rings are smaller than intended by the wobbling control. Note that abnormal rings are either smaller or larger in diameter, and the banding marks were confirmed to occur in both cases.

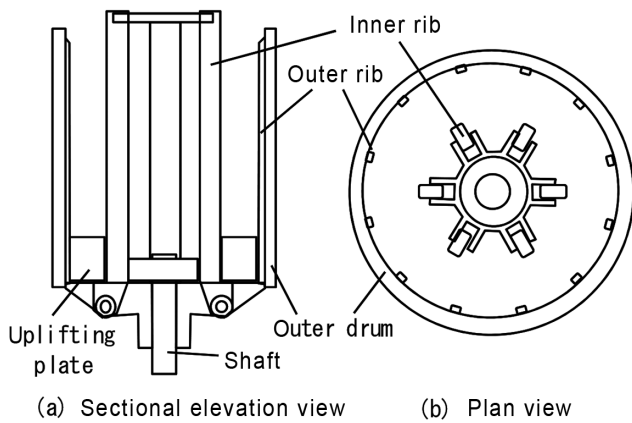
Fig. 3 Pouring reel before renewal

Figure 3 schematically shows the pouring reel before the renewal. Vertical members, called ribs or sometimes pins, were provided to hold the coil from the inside and the outside at equal intervals. Whereas the outer ribs were mounted movably in the radial direction to produce coils of two different outer diameters, the inner ribs were fixed at their lower ends to the bottom of the drum, and tied to each other horizontally at the top ends. The bottom plate of the space in which the coil is wound is vertically movable so that, before receiving an incoming bar, it is set at the best position calculated from the weight of the coil to prevent the tail end of the bar from protruding outside the reel.

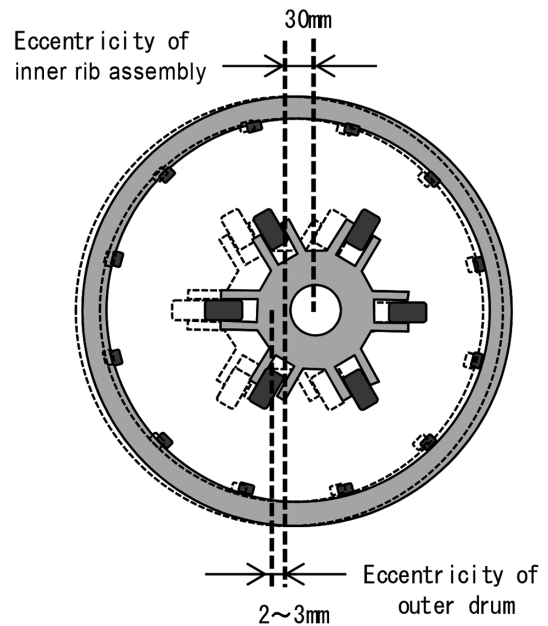
Fig. 5 Measured eccentricity of reel

We presumed that the cause of the abnormal ring diameter was the decentering of the reel due to deformation of the ribs and their support structures, and investigated the decentering during rotation. Figure 5 shows the investigation result: the eccentricity of the inner rib assembly was as large as 30 mm at worst, which supposedly led to the steel being wound at a speed not intended by the wobbling

control, and caused temporary fluctuation of the ring diameter, which then adversely affected the diameters of subsequent rings. The decentering was found to result from thermal deformation of the ribs proper and the wear of their support structure. The parts fixing the ribs were replaced with new ones to correct the decentering, but the situation did not improve significantly. From this, we concluded that it was necessary to review the entire reel structure to improve the structural strength and replace them with new ones.

To solve the problems described in the previous Section 3, the pouring reels, their drive motors and the main control system were replaced with new ones. The pouring reels were ordered from Danieli Morgardshammer in appreciation of the rich supply of references of this type of machine worldwide including Japan. **Figure 7** shows a vertical sectional view and a plan view of the reel after the renewal, and **Table 1** its main specifications. The features of the new machines are explained below.

To solve the problem of the decentering of the ribs permanently, the machine structure was changed from the rib type to the drum type, which is more robust and less prone to the decentering by aging than the rib type, although it is more expensive. Another advantage of the drum type is that the bar is held by the inner surface of

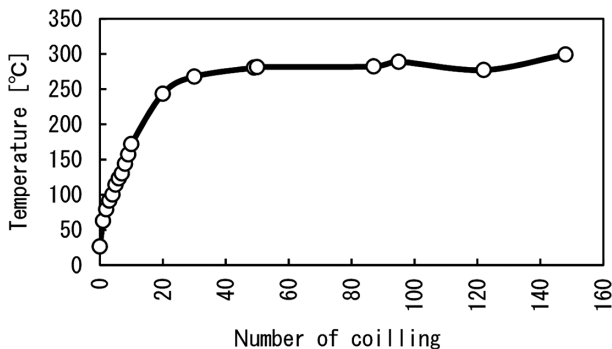
**Fig. 6** Change of rib surface temperature

During coiling using the old pouring reel, the ribs contacted the hot product and their surfaces were roughened by seizure at high temperature. When a coil was wound to the end and lifted up from inside the reel, the coil scratched the ribs and because of the rough rib surfaces, oval depressions having a rough surface, or rib marks, formed at the bar surface on the outer side of the coil. **Figure 6** shows the change in the surface temperature of the outer rib surfaces during continuous operation. Since the old reels did not have any measures to cool the ribs, the rib surface temperature often exceeded 250°C after coiling roughly 30 bars, and in this temperature range, the surface roughening advanced and the depth of rib marks tended to increase. For this reason, after coiling a product lot of 500 t, the mill line operation was temporarily stopped, the reels were cooled with water spray from above, and then after the machine became sufficiently cool, operators went down to the reel inside to polish the rib surfaces. This, besides being unpleasant work in a hot environment, greatly decreased the productivity of the mill line, and for many years effective measures to dispense with the stoppage were investigated.

To prevent the recurrence of seizure marks like the rib marks before the revamp, measures for cooling the outer and inner drums were newly introduced. The outer drum was designed to be cooled with water spray from outside, and the inner drum to consist of sections of water tanks so that they were cooled by the vaporization of the water. Thanks to these measures, it became possible to keep the reel portions in contact with the product cooled during coiling operation.

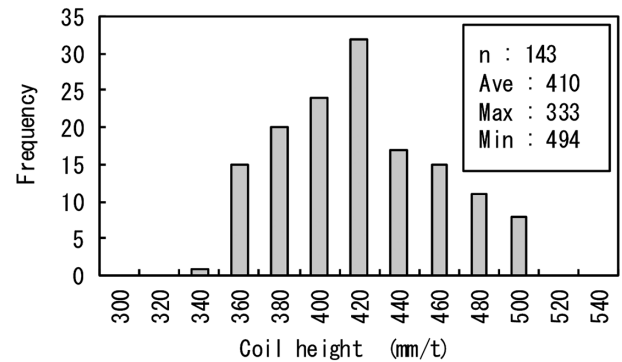
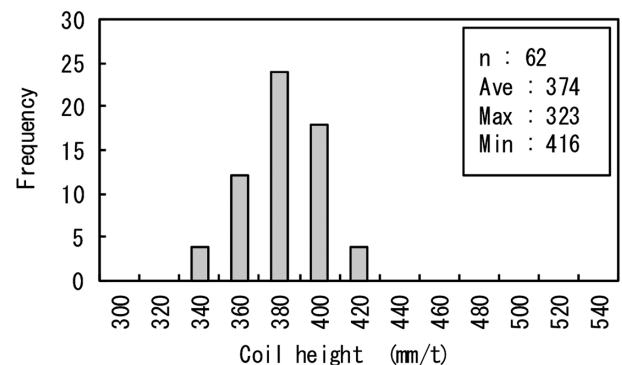
When coil packing density is low, rings move easily in the coil during banding, increasing the risk of banding marks. In consideration of this, the improvement effects of the revamping were evaluated using unit coil height (mm/t, coil height after banding divided by coil weight) as an indicator of the coil packing density. As a typical example, Figs. 8 and 9 compare the unit coil heights of bars in the coil of JIS S10C, 19 mm in diameter, before and after the renewal. After the revamp, the unit coil height decreased roughly by 9%, on average, realizing an improvement in the coil packing density. Similar results were obtained with products of other sizes. In addition, the eccentricity of reel rotation has been suppressed and the occurrence of abnormal ring diameters deviating from the wobbling control decreased thanks to the renewal of the reels.

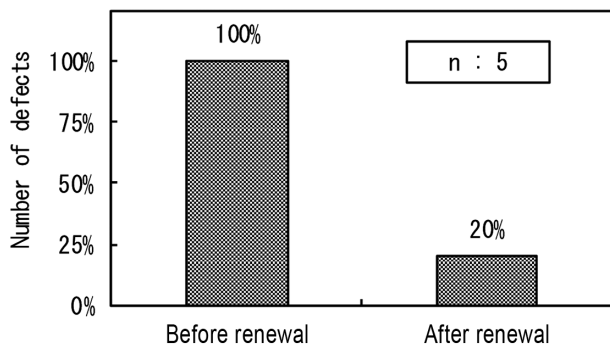
Fig. 10 Number of defects by banding (19 mm dia. S10C)

Since the above looked promising for decreasing the banding marks of coils, we examined the actual banding marks off line along the entire lengths of S10C bars in a coil, 19 mm in diameter, produced before and after the revamp. Figure 10 shows the result: the occurrence of banding marks decreased by 80% after the revamp, realizing the positive effect of increased coil packing density. The increase in the coil packing density proved effective also at improving coil appearance. Thus, the revamp of the bar-in-coil line has produced significant improvements in surface defects and coil appearance, important quality items of bars in coil.
