# Long-term Follow-up Survey on 3%Ni-added High-performance Weathering Steel (NAW-TEN™15) in High Airborne Salt Concentration Environment and Risk Management of Weathering Steel Bridges

## Abstract

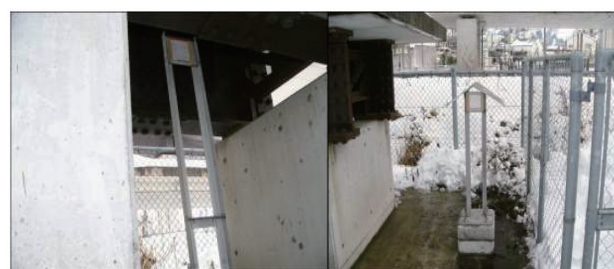
(a) Inside of the bridge

(b) Outside of the bridge

Fig. 5 Airborne salts measurement situation at the inner and outer girder of the simulated bridge

Figure 3 shows the appearance of the 3%Ni-added high-performance steel (subjected to supplemental rust controlling surface treatment) that was applied to the viaduct of Hokuriku Shinkansen over the Hokuriku Highway (hereinafter referred to as “the bridge”) 15 years after construction of the bridge. The bridge has a closed-type girder structure (4-span continuous composite box girders “vessel shaped girders” and 3-span continuous concrete-filled steel pipe combined girders “steel girders”) to secure adequate ventilation and drainage. Thus, the bridge is constructed in such a way that most part of it is effectively cleaned by rainwater. In fact, the bridge is still in good condition even after 15 years. In the neighborhood of the bridge, an exposure test using test pieces and a simulated bridge prepared from newly-fabricated steel plate was started before the bridge was built at the site. The exposure test has been continued to examine the secular changes of the weathering steel. The amount of adhered salt to the inner and outer the girders of the simulated bridge was measured for one year. It was 0.244 mdd on average for the outer girders (under condition without eaves) and 0.036 mdd on average for the inner girders (under condition protected by eaves at the side) (Figs. 5 and 6).<sup>8)</sup>

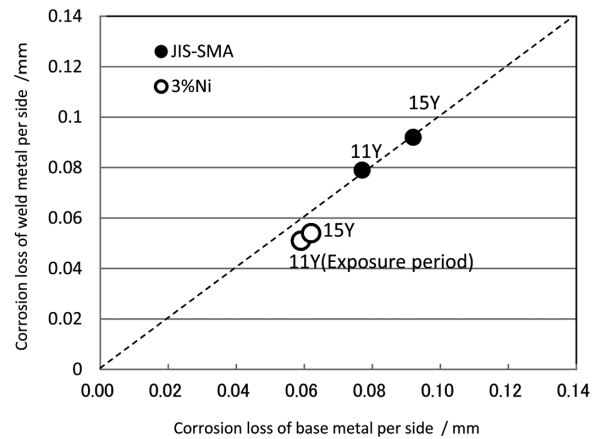
Fig. 10 Comparison of corrosion loss between base and weld metal

Figure 9 shows the appearances of test pieces of the welded joint of 3%Ni-added high-performance weathering steel after the exposure test. Figure 10 compares the corrosion loss between the base metal and the welding material. It could be confirmed that even after 15 years, both the base metal and the weld zone of the test pieces remained normal in appearance after the removal of rust and that there was very little difference in corrosion loss between the base and weld metals.

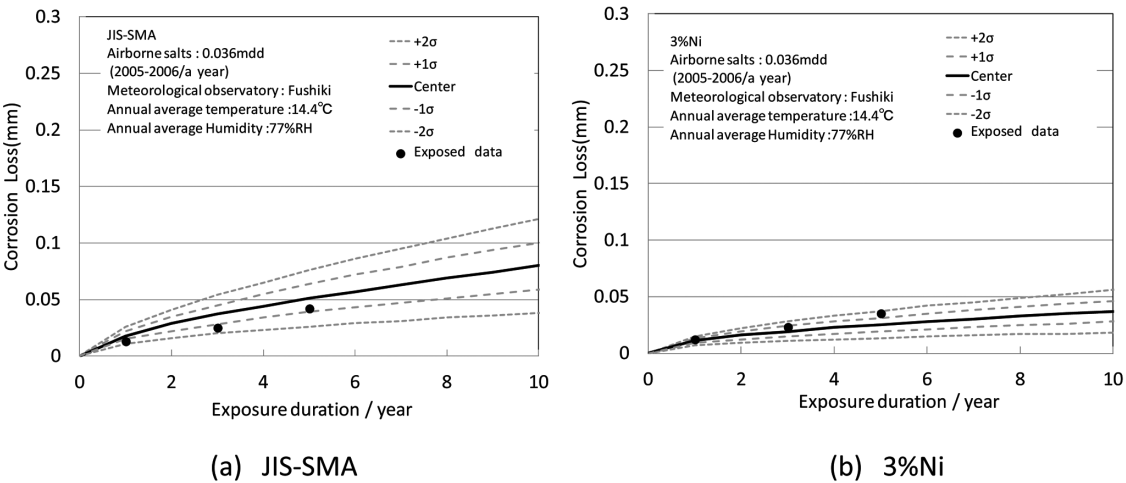
Fig. 14 Comparison of corrosion loss between forecasting curve and measured data

YOSOKU permits the prediction of the amount of long-term corrosion loss in shelter environment that is extremely corrosive. With the aim of confirming the reliability of YOSOKU, the results of corrosion loss prediction by YOSOKU were compared with the results of a horizontal exposure test conducted for five years from July of 2006 by shelter condition under the inner girder of the simulated bridge. The environmental conditions used in the comparative study were as follows. The amount of airborne salt is the measured value (0.036 mdd)<sup>8)</sup> shown in Figs. 5 and 6; the meteorological factors are based on data supplied from Fushiki Meteorological Observatory nearest to the test site; and the amount of sulfur oxide is 0.15 mdd, decided considering the environment of the locality.<sup>13)</sup> The results of prediction of long-term corrosion loss by YOSOKU and the results of the exposure test are shown in Fig. 14. The measurement data for both JIS-SMA and 3%Ni-added high-performance weathering steel fit within  $\pm 2\sigma$  of the prediction curve, proving the validity of predicting the corrosion loss by YOSOKU.

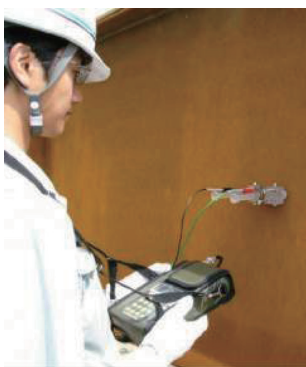
Fig. 15 Ion transfer resistance measurement (RST)

In the inspection/diagnosis of a weathering steel product, it has been a common practice to visually check the condition of rust formed on the steel surface. For that practice based on the appearance rating system,<sup>20)</sup> it is necessary to directly and quantitatively examine the condition of formation of protective rust. To solve that problem, Nippon Steel & Sumitomo Metal has developed an instrument (RST) for measuring the ion transfer resistance of rust (Fig. 15). Nippon Steel & Sumitomo Metal has proposed a scheme for the quantitative judgment of the condition of rust formed on the steel surface by evaluating the ion transfer resistance and thickness of rust (see Fig. 8).<sup>13-15)</sup> This technique is unique, in that it permits the quantitative determination of the condition of rust through an electrochemical analysis, rather than the subjective judgment based on visual check of the appearance. Registered in the New Technology Information System (NETIS) of the Ministry of Land, Infrastructure and Transport, it is a promising technology applicable as a tool for inspection (Reg. No. KT-110072-A).

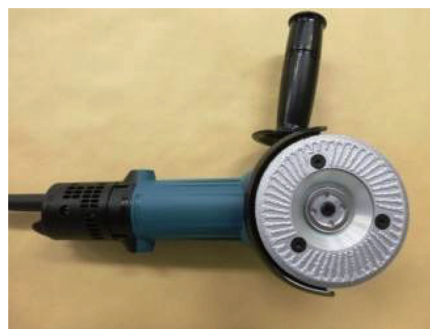
Fig. 16 Grinder with manmade diamond grains

To solve the above problems, Nippon Steel & Sumitomo Metal has developed a grinder with manmade diamond grains<sup>22)</sup> (Fig. 16) that is capable of efficiently removing sticky rust from the surface of weathering steel plate and a zinc-rich paint<sup>23)</sup> that displays good anticorrosion performance even if the concentration of salt deposit on

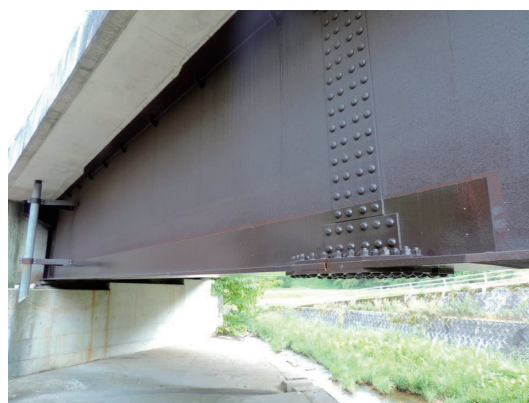
Fig. 17 Example for repaired painting

the steel surface is higher than the conventional reference (50 mg/m<sup>2</sup>). Based on the above achievements in technology development, a procedure for proper repair painting of weathering steel bridges has been proposed and put into practical use (Fig. 17).<sup>21)</sup>
