Technology

Corrosion Protection for Offshore Steel Structures Using a Metallic Sheathing Technology with Seawater-resistant Stainless Steel

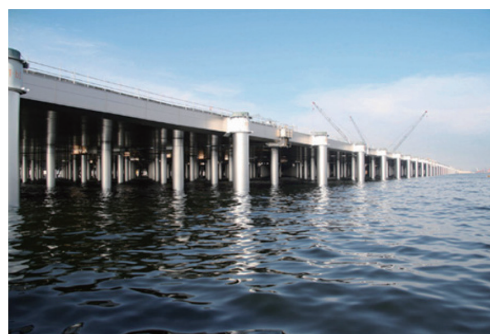
Fig. 1 Application of stainless steel sheathing to offshore steel structures

Offshore steel structures such as wharfs, breakwaters, offshore airports, and tanker berths are important items of social capital and must last for a long time. They are welded structures of homogeneous and stable-quality steels and have many advantages such as a high freedom of design and a short period of construction. The seas are very corrosive environments for steels. Long-term use of offshore steel structures requires appropriate corrosion protection measures. Especially, exceptionally reliable corrosion protection methods must be applied to steel members used in splash and tidal zones that are severely corrosive environments. Nippon Steel Engineering Co., Ltd. developed a seawater resistant stainless steel sheathing method for the corrosion protection of offshore steel structures with an exceedingly long design service life of 30 to 100 years. This method is more advantageous than conventional organic coating corrosion protection when the maintenance cost for damage by the collision of driftage and aging of materials themselves are considered. It has been applied to many offshore steel structures, including the pier of runway D at Haneda Airport (Fig. 1).

The seawater resistant stainless steel sheathing method has been applied to many harbor jacket structures, including runway D at Haneda Airport (Fig. 1).

Runway D at Haneda Airport was constructed offshore and put into operation in 2010. It is located near the mouth of the Tama River and about one-third of it is a pier structure to secure the flow of the river water. The pier structure is constructed of a grid-pattern steel girder superstructure to provide a large flat surface; 198 steel jackets constructed of truss substructures of legs and braces to support the superstructure; and 1 165 foundation piles to secure the jackets. **Figure 13** shows the appearance of the jacket structure before marine transport. At runway D at Haneda Airport, the stainless steel sheathing described here is applied to the surfaces of all of the 1 165 jacket legs (total area of 114 000 m²) at the pier. The SUS 312L sheets for all of the stainless steel sheathings were bright annealed at the Yamaguchi Works of Nippon Steel Stainless Steel Corp., so that the oxide scale formed during the annealing of the SUS 312L sheets would not adversely affect the steel members of the pier structure of runway D with a design service life of 100 years. Since then, bright annealed SUS 312L sheets have been used for all of the sheathings installed by Nippon Steel Engineering, regardless of the length of the design service.

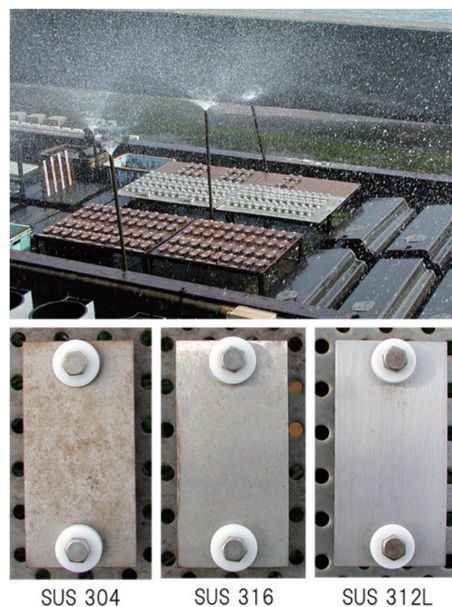
Nippon Steel Engineering has conducted various exposure tests to evaluate the corrosion resistance of the sheathing material in actual marine environments. Figure 3 shows the results of a four-year shower exposure test with actual seawater at a long-term exposure test site in Yokosuka City, Kanagawa Prefecture. The shower exposure test was conducted to simulate cyclic drying and wetting in the splash zone. The comparison materials SUS 304 and SUS 316 corroded, but the SUS 312L retained its metallic luster and was con-

Fig. 3 Seawater shower exposure test²⁾

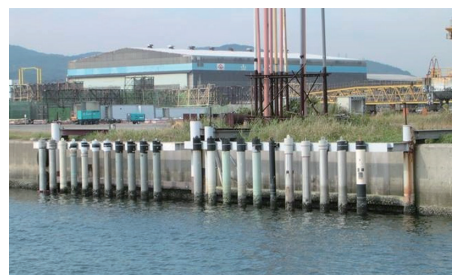
Fig. 4 Exposure test in coastal area

firmed to have excellent corrosion resistance. As shown in Fig. 4, exposure tests have been performed on the SUS 312L since 1997 at a wharf in the Wakamatsu Plant of Nippon Steel Steel Structure Co., Ltd. The SUS 312L is confirmed to have long-term corrosion resistance in the marine environment.²⁾

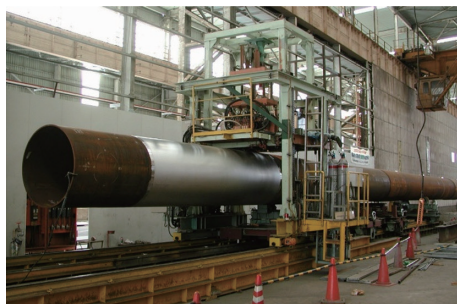
Fig. 8 Equipment for automatic combined welding^{4,5)}

The SUS 312L sheets can be joined to the steel pipes by indirect seam welding alone. The welded joint thus produced may become a crevice structure and may initiate crevice corrosion, depending on the use environment. For this reason, the sheathing sheets are joined to the steel pipe by indirect seam welding. At the same time, the plasma welding process is also applied to eliminate the crevice structure.⁴⁾ The plasma welding process uses the Inconel 625 as the welding material. The combined indirect seam-plasma welding process is schematically illustrated in Fig. 7. The ends of the indirect seam welded joint are sealed by tungsten inert gas (TIG) welding to ensure watertightness. Table 3 shows some of the combined welding conditions. A high welding speed of 80 cm/min is achieved with 0.4 mm thick SUS 312L sheets.⁵⁾ Figure 8 shows the combined indirect seam-plasma welding equipment.^{4, 5)}

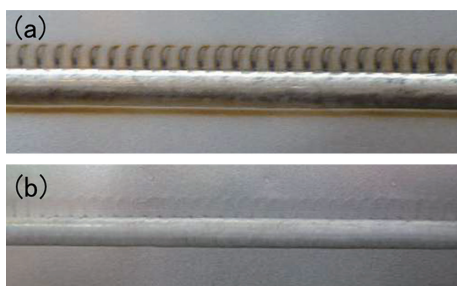
Fig. 10 Appearance of weld bead after electrolytic polishing
(a) Before polishing (b) After polishing

High-temperature oxidation regions are formed in the welded joint and in the nearby regions under the effect of the welding heat as shown in Fig. 10(a). The corrosion resistance of the high-temperature oxidation regions may be lower than that of the stainless steel base metal. The high-temperature oxidation regions are thus removed by electrolytic polishing after welding. Figure 10(b) shows the welded joint surface condition after electrolytic polishing. It can be seen that the high-temperature oxidation regions near the welded joint are completely removed by electrolytic polishing.

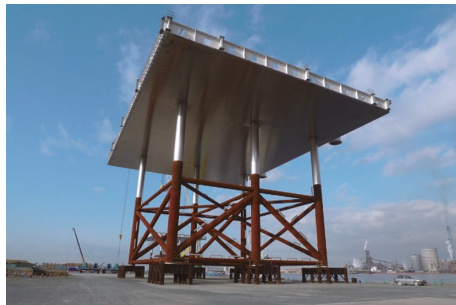
Fig. 13 Jacket structure
