Report on the Nagoya Works power failure accidents -- The causes and preventive measures --

November 25, 2014
Nippon Steel & Sumitomo Metal Corporation

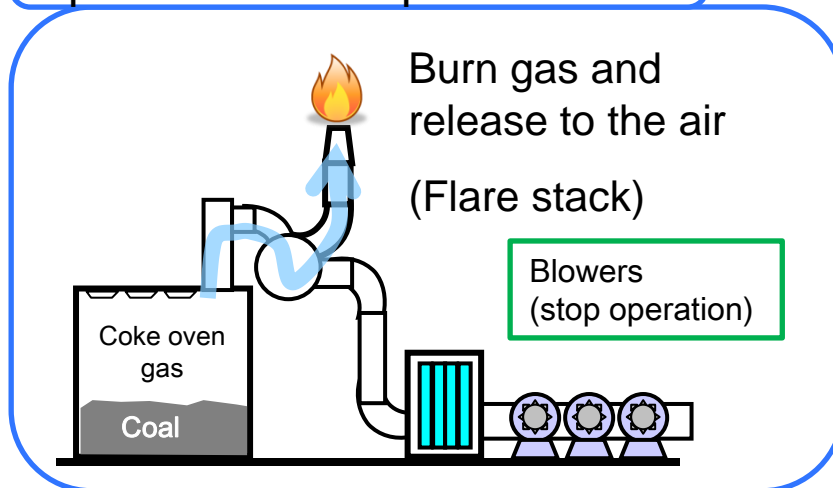
When gas blowers stop operation due to power failure

Even when a power failure occurs, gas generation from the coke oven will continue for a while. There would be a huge accumulation of coke gas, which has to be released to the air.

The gas is burned off in the flare stack above the coke oven.

If the gas is not completely burned off, it turns into smoke including soot.
