Report on the Investigation of the Nagoya Works Coke Fire Accident and Power-Receiving and Distributing Equipment

April 7, 2015
**Nippon Steel & Sumitomo Metal
Corporation**

I. Report on the Coke Fire Accident (Coke Accident Response Committee)

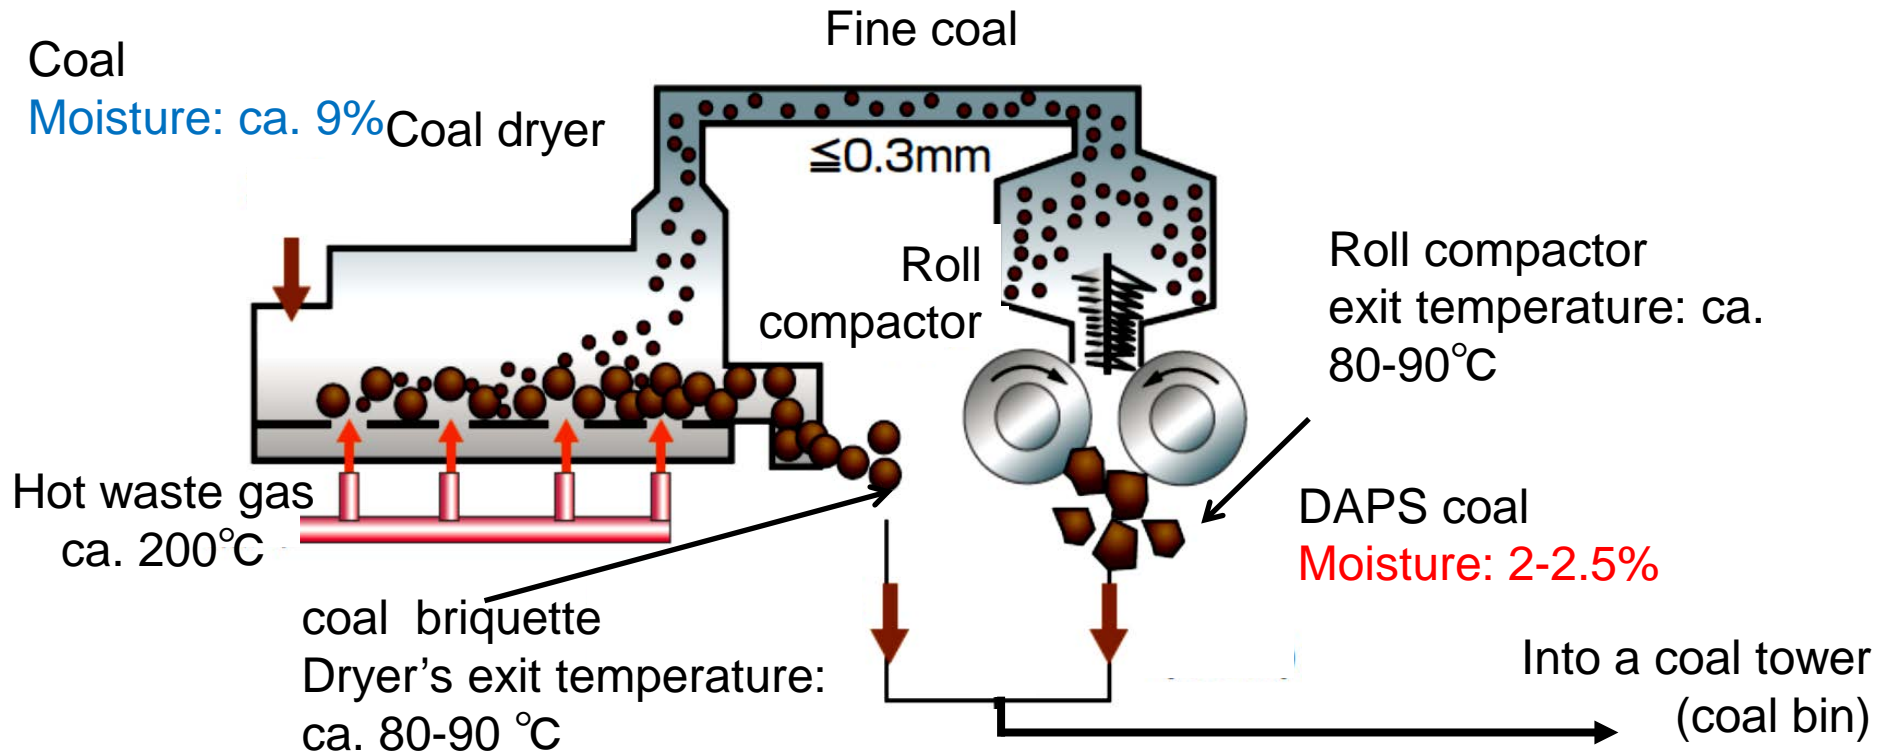
1-(2) Outline of DAPS Facility

- 1) Coal is dried in a coal dryer by blowing in hot waste gas (ca. 200°C) from the bottom.
- 2) Separation of fine coal from coarse-grain coal.
- 3) Briquetting the fine coal into agglomerate by a roll compactor.
