Damage by East Japan Earthquake and Tsunami in 2011 to Port Facilities and Their Restoration

Abstract

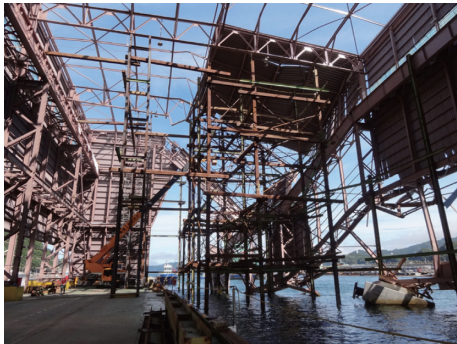
Photo 9 Temporary structure for repairing building

Three of the five dolphin-type foundations of the berth building on the sea side were extremely distorted in the underwater parts and their footings sank under the water. They were supported by oblique steel pipe piles 800 mm in diameter each, but from the mode of the distortion, pulling them out to remove them was difficult; therefore, they were cut at the sea-floor level, and two pipe piles were newly driven for each of the three foundations, vertically between the old oblique piles as illustrated in **Fig. 6**. This time, the pile diameter was

New structure frames were installed using a 400-t crawler crane capable of handling fabricated frame pieces of regular size in a normal working radius over the existing structures. Thus, the building was restored to high dimensional accuracy, in which work parts were assembled sometimes piece by piece while their alignment and

levelling with reused portions were confirmed.

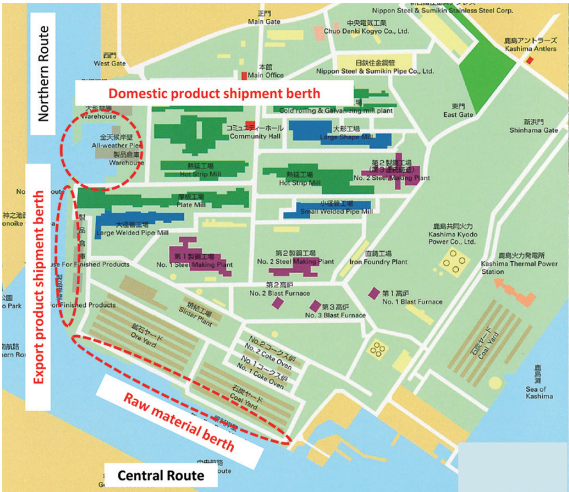
Fig. 7 Layout of Kashima Works

Figure 7 shows the layout of the entire works, and Table 1 outlines the port facilities and the damage inflicted on them. One of the characteristics of the damage by this earthquake is that, besides the damage to structures by the seismic force, tsunami and ships unleashed by it struck the cranes and other port facilities as in the case of Kamaishi, which added to the purely seismic damage. Figure 8 shows the change in the tide level at a seawater intake of the works; the water sank to as much as 6 m below the datum level (DL) at the lowest. The drifting of many ships by the tsunami was confirmed later with photographs and word of mouth. Photo 10 shows a loading crane for export products that collapsed after being hit by a drifting ship, and Photo 11 shows a damaged quay protection of steel sheet piles due to the ship collision.
