# Renewal of Pouring Reels of Bar Mill Plant

## Abstract

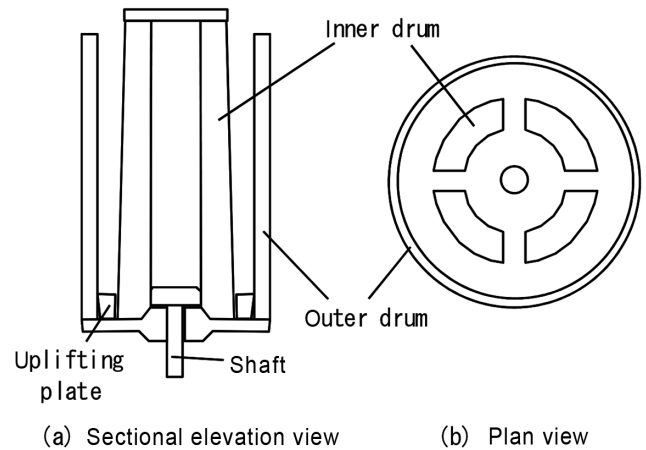
**Fig. 7** New pouring reel

To solve the problem of the decentering of the ribs permanently, the machine structure was changed from the rib type to the drum type, which is more robust and less prone to the decentering by aging than the rib type, although it is more expensive. Another advantage of the drum type is that the bar is held by the inner surface of

the outer drum rather than at points by the outer ribs, and surface defects are less likely to occur. On the other hand, to produce coils of large and small diameters, which was possible with the rib type reels, with the drum type it is necessary to change the drum, and this did not seem viable considering the operators' work load and the line stop required for the drum change. Since the majority of the coils were of the larger outer diameter type before the revamp, the coil diameter was unified to the larger through consultation with clients, and selection of the drum type was enabled. The drum diameter of the new reels was set slightly smaller than the larger outer diameter before the renewal, and by reducing the coil thickness (the difference between the inner and outer diameters), increase in the packing density was envisaged.
