Change in Microstructure and Properties in the Rolling Contact Fatigue of Bearing Steel

Abstract

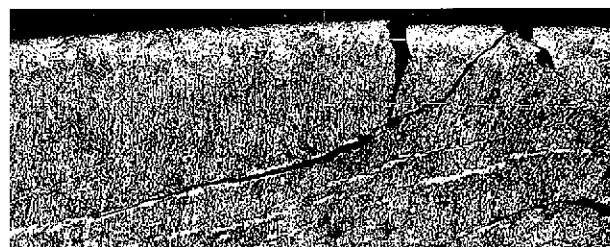
Fig. 1 Peculiar microstructure and crack 50μm

However, with the rapid progress made in high cleanliness of bearing steel in recent years there has also been improved longevity. As bearings are being used under ever increasingly severe high contact stress, the peculiar microstructures shown in Fig. 1 are generated by the process involved in rolling fatigue. The phenomenon occurs where this peculiar microstructure is the path for the
