# Improvement of Billet Magnetic Particle Testing System and Surface Defect Analysis System

## Abstract

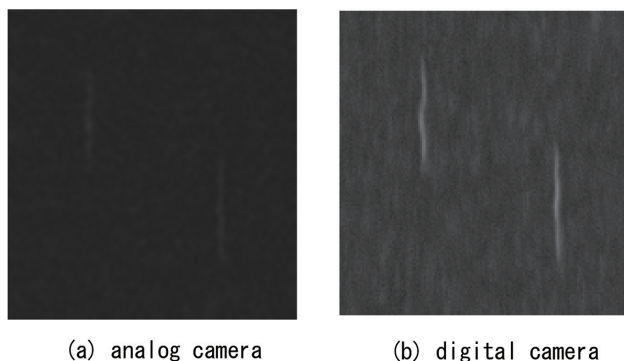
Fig. 3 Defect image of (a) analog camera and (b) digital camera

Camera images taken before and after the renewal are shown in

**Fig. 3.** In the image taken by a conventional analogue type camera, the brightness of the defect is poor and minor defects in particular were unclear and difficult to detect. As a countermeasure, digital cameras were introduced, the optical lenses and the filters were renewed, and the shutter speed and the internal software of the camera were optimized. As a result thereof, the brightness of the defect image was increased, further clarifying the image, and the detectability of minor defects was improved.

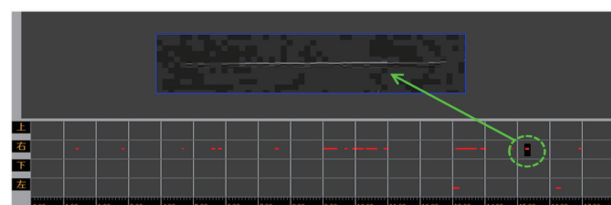
Fig. 4 Flaw image of automatic detector

In the introduced AMG defect analysis system, such information as the image of the defect form, location, size and code are stored in the system, which enables us to grasp the state of the occurrence of defects. An example of the defect image developed by the AMG defect analysis system is shown in Fig. 4. Furthermore, the system is constructed as shown in Fig. 5, and access to the state of defect occurrence and defect images for confirmation immediately after AMG inspection has been made possible for the respective production division and quality control division via the in-steel-works OA network.

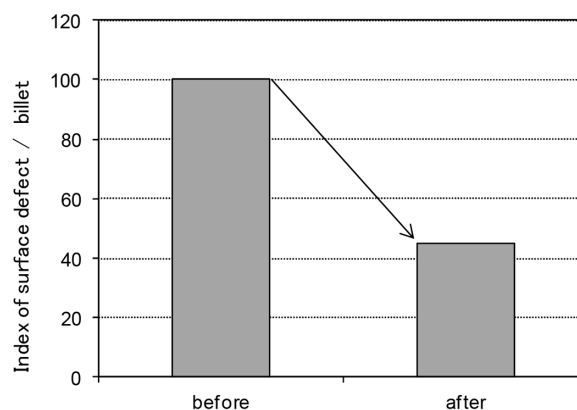
Fig. 6 Index of surface defect of before and after improving

By utilizing the system, early identification of materials with abnormal surface defects has been enabled. Furthermore, whenever quality abnormality takes place, a quick and accurate analysis of the cause and study on the countermeasures have become possible due to the detailed billet surface defect data stored in the system. As shown in Fig. 6, with the effective implementation of the quality improvement measures, the billet quality has been improved and the

billet surface defects have been greatly reduced.
