Present Status and Future of Equipment Diagnosis Technology for Iron- and Steelmaking Plants

Toyoki YAMAMOTO* Shintaro KANOKO Kazumichi WADA Akira HIGUCHI

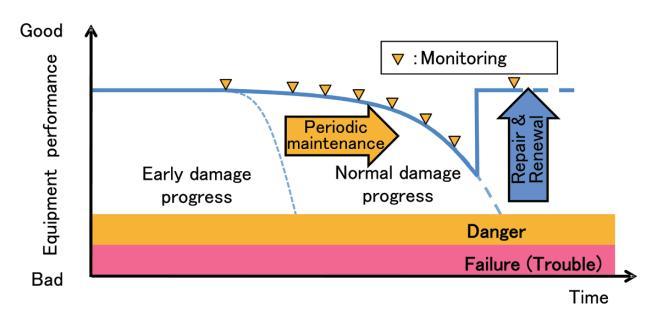
Fig. 1 Concept of condition based maintenance

To always keep the facilities in a stable working order and reduce the costs of maintenance under the above conditions, predictive maintenance, or condition-based maintenance (CBM, see **Fig. 1**), whereby equipment damage is kept under watch and the timing of repair is scheduled, is essential. ¹⁾ As the measures to quantitatively detect symptoms of equipment damage at an early stage, Nippon Steel & Sumitomo Metal Corporation has developed various technologies and devices for equipment condition diagnosis and applied them to daily field practice.

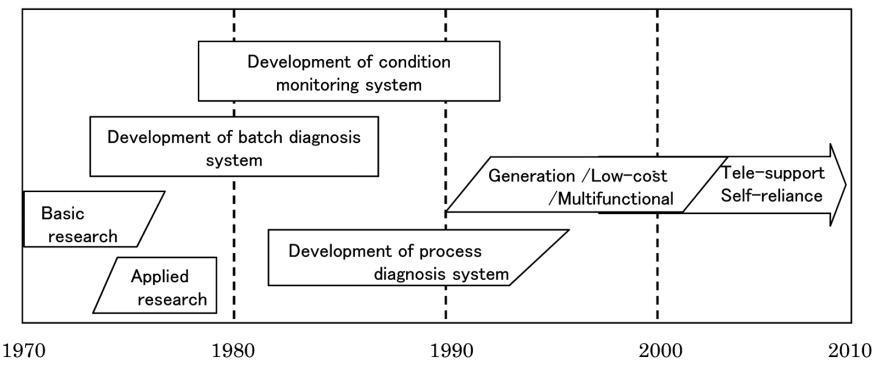
Fig. 2 History of diagnostic technologies

Nippon Steel & Sumitomo Metal began technical development for the field application of such plant diagnosis technology in the 1970s, and ever since, has introduced ELESMARTTM and other portable equipment diagnosis devices to different production lines at its steelworks. These facilities, more than 2000 in number, now constitute an indispensable tool for field maintenance activities. Based on equipment diagnosis technology obtained through the use of these portable devices, methods were developed for online diagnosis of plant equipment precisely and continuously around the clock in the 1980s, which were then refined in the 1990s for wider application and functions and lower costs and widely spread to the plant floors. Such online diagnosis systems now cover more than 100 plants at different works of the company, forming indispensable part of the field maintenance ^{3,4)} (see **Fig. 2**).

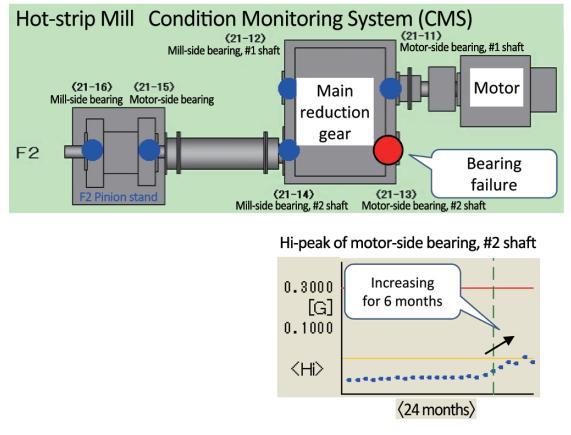
Fig. 3 Detection of bearing damage in main reduction gear box for finishing mill

At a blast-furnace-based integrated steelworks in Japan, the continuous hot rolling mill plant constitutes an obligatory process composed of a single production line, and an equipment trouble there has influence over the production of the entire works; a failure especially of any one of its rolling mill stand is likely to cause a long plant stop or a significant fall in production. For this reason, all the continuous hot rolling mill lines of the company have online continuous monitoring systems with vibration sensors provided for every mill stand, especially the drive system. **Figure 3** shows a monitor-

ing system applied to the main reduction gear box of a finishing mill stand (F2). In a specific case given here, starting from six months before a scheduled change of a bearing, a diagnosis parameter on a monitoring device, say the Hi value, of the unit began to go up gradually, and at a direct inside inspection using a fiber scope, flaking was found at the raceway surface of its outer ring (see **Fig. 4**). In this case, the bearing was put under intensive control, the lubricant feed rate was increased, and it was kept in working order till the previously scheduled change up to its designed service life and without hindering production.

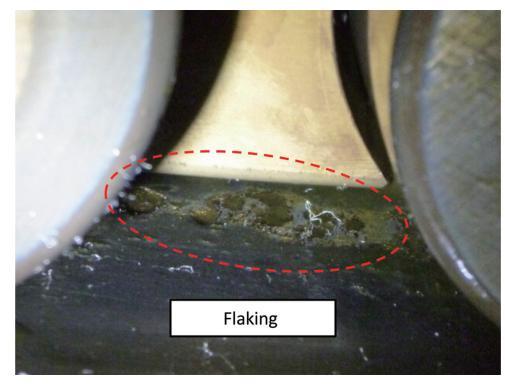
Fig. 4 Flaking of outer ring raceway

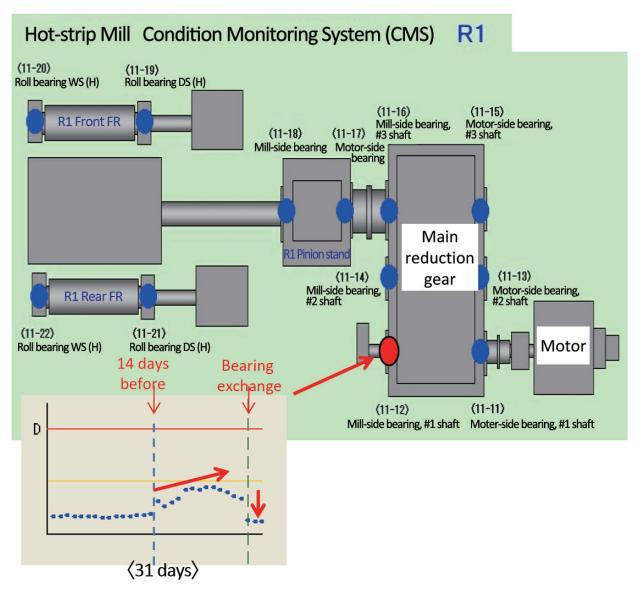
Figure 5 shows another example, diagnosis of the main reduction gear of a roughing mill stand. In this case, too, the Hi value of a

bearing began to increase about two weeks before its scheduled change, and it was closely examined to find the cause, wherein acoustic signals of a specific frequency pointing to retainer damage were identified, and the bearing in question was replaced with a new unit at a periodical repair of the plant a few days thereafter. During the replacement work, a part of its retainer was found to have broken as had been suspected (see **Fig. 6**). As seen with these examples, an alarming signal makes it possible to prepare replacement parts and the personnel for repair in order to prevent secondary damage such as the failure of a gear or a shaft in the same gear box. More than 20 machine damage cases similar to the above are detected beforehand and taken care of at all the continuous hot rolling mill plants of the company every year, preventing roughly 120 hours of line stops.

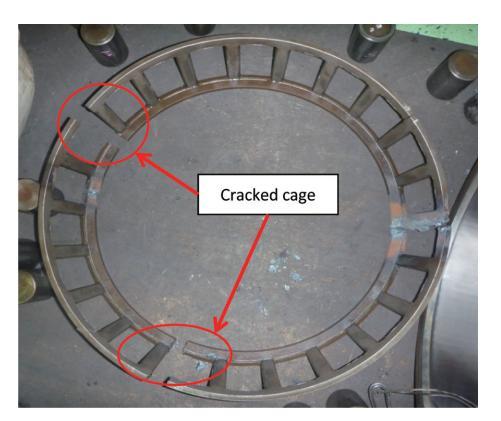
Fig. 6 Cracked bearing cage in main reduction gear box for roughing mill

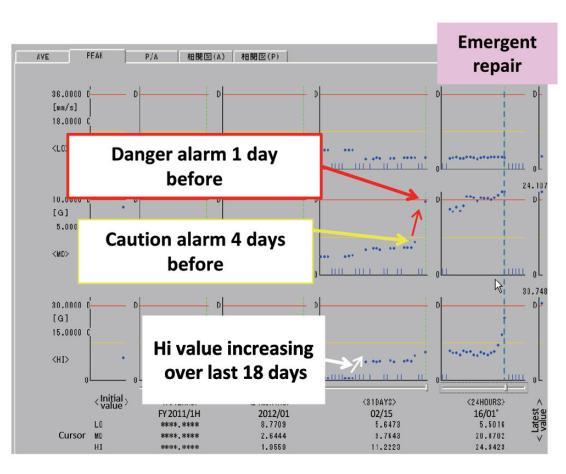
Fig. 7 Trend graph of speed increasing gear box

Figure 7 shows plotting of vibration trend monitoring of a speed-increasing gear box. The Hi value, which indicates damage of the bearing in question, went upwards from the base line; the MD value (mid graph), which indicates the acceleration in all frequency bands, rose to the caution level 14 days thereafter, and further to the danger level the following day; as a countermeasure, the lubricant feed rate was increased, and the cause of the anomaly was looked for using the online automatic precision diagnosis function. Eventually, signs pointing to damage of a bearing roller were detected as shown in **Fig. 8**, and preparations were made for replacement of the bearing. In the meantime, the Hi value (lower graph) suddenly began to rise rapidly, and the mill line was stopped for quick replacement of the bearing. The dismounted bearing was found to have flaking in one of the rollers as indicated in the precision diagnosis (see **Fig. 9**). In this example case, the part change before breakdown

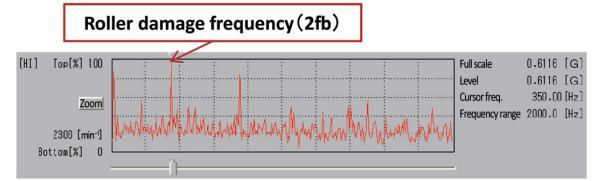
Fig. 8 Result of precise diagnosis

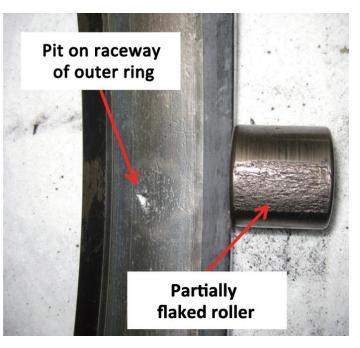
Fig. 9 Flaking of roller bearing

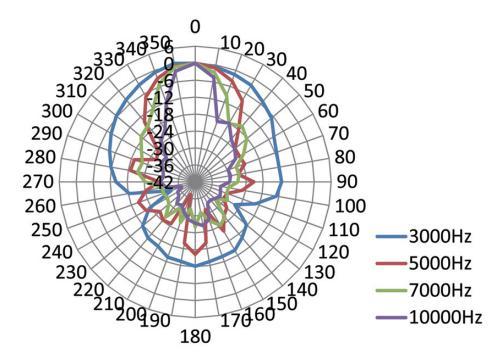
Fig. 10 Polar pattern of microphone

The microphone used for the developed method is parabolic and has directional characteristics suitable for collecting desired signals, reducing the background noises from irrelevant sources and those of compressed air, cooling water and the like in the environment of plant floors. **Figure 10** shows the directional characteristics of the microphone, and **Fig. 11** the acoustic damping of sounds of different frequencies coming from different directions. A common microphone is not directional, and catches sounds coming from any directions with little damping, and the curves of Fig. 10 would be nearly circular for different frequencies with such microphones. In contrast, a parabolic microphone exhibits stronger directionality at higher frequencies. The parabolic microphone for the developed method was designed such that, with a sound source 1 m away, the

damping of a sound at 10 kHz frequency would be 3 dB when coming from 10° from direction 0, 10 dB, approximately, when coming from 20°, and more than 20 dB when coming from the back. (2) Acoustic diagnosis of bearings

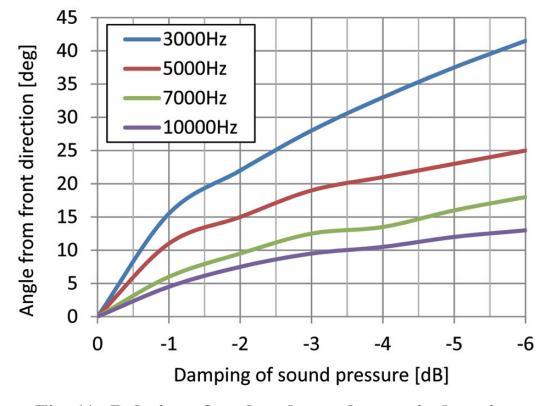
Fig. 11 Relation of angle value and acoustic damping

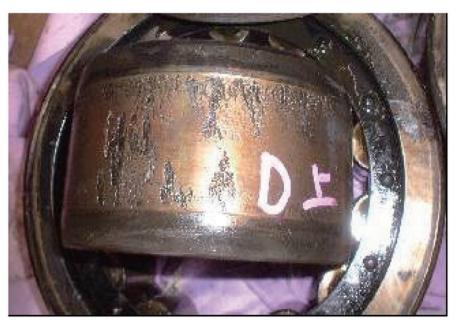
Photo 1 Overhaul inspection of defected bearing

Figure 12 shows an acoustic measurement of a degraded bearing, and Photo 1 the appearance of the same bearing at an overhaul. A wave pattern characteristic of a defective bearing was captured among other sound patterns from a distance up to several meters from its housing in a noisy outdoor environment, and based on it, roughening of a raceway was found.

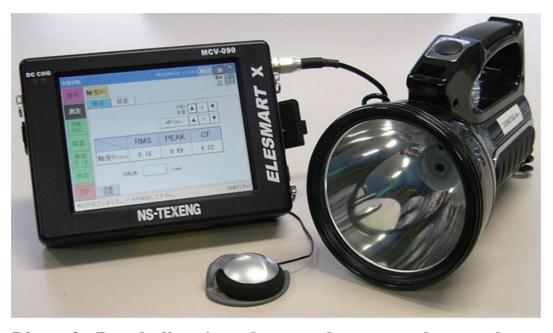
Photo 2 Parabolic microphone and compact data analyzer (By courtesy of Nippon Steel & Sumikin Texeng. Co., Ltd.)

Through many times of verifications as the above and repeated field tests in equipment in commercial operation, the method has been brought up to daily practice worthiness; this function has been incorporated as an optional function of ELESMARTTM X (see **Photo 2**), a model of multi-function portable equipment diagnosis device commercialized by Nippon Steel & Sumikin Texeng. Co., Ltd. 5.1.2 Service life prediction of crane wires

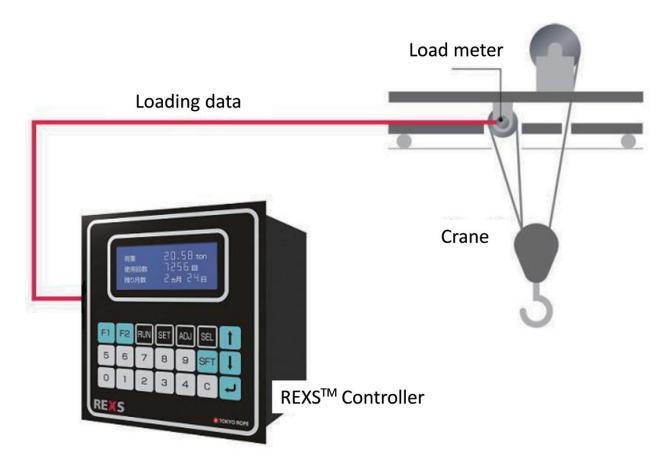
Fig. 13 Wire rope residual life monitoring system (REXSTM)

ber of lifting and the evaluation of strand damage at periodical inspection. In the meantime, however, problems came to be felt increasingly strongly, and corrective measures were called for regarding the number of lifting exceeding the prescribed number of use due to increase in production at the plant in question, consequent increase in over-loading and excessive maintenance due to repair/discarding standards on a safety side. To solve the problems, a system to control the service life of steel wire ropes, REXS™, has been developed jointly with Tokyo Rope Manufacturing Co., Ltd., wherein cumulative fatigue of a wire is evaluated based on loading information from a load gauge installed in the wire route (see Fig. 13), brought up to practice worthiness, 5) and applied to some of important cranes. This system is capable of continuously calculating the remaining service life (number of lifting) of a crane rope based on the specifications of the crane, the rope, and sheaves and by connecting to the load gauge.

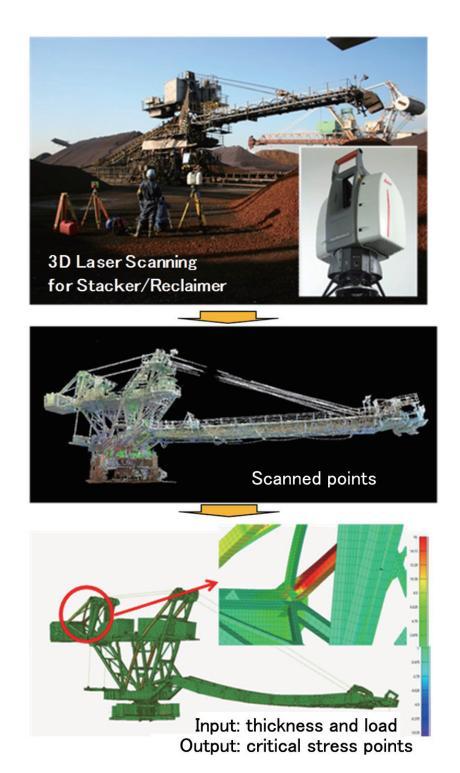
Fig. 14 Structure diagnosis by 3D laser scanning and FEM

Most of the steelworks of Japan were constructed 40 to 50 years ago, and many of their production facilities, especially those comprising steel structures exposed to the elements, are aged and face problems of long-term damage due to corrosion, etc. In consideration of this, efficient secular diagnosis methods applying the latest dimensional survey and non-destructive inspection technology have been developed and practiced. For instance, the sag of aged support structures for belt conveyers or the displacement of the rails for coke oven machines is measured by 3D laser scanning to prevent conveyer meandering or correct the position accuracy of the machines with respect to coke oven chambers. Further, to evaluate the secular of moving machines in raw materials yards such as stackers and reclaimers, the combination of 3D laser scanning and numerical analysis is effective at quickly assessing the strength of structural members that have thinned through years of corrosion; this has been commercially applied to decide the priority of repair of machine parts and renewal of aged units (see Fig. 14).

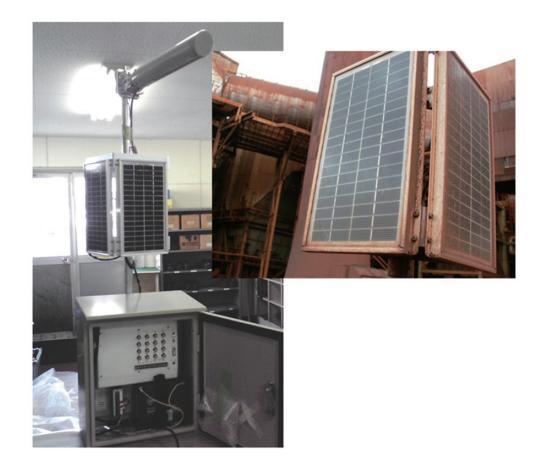
Photo 3 Solar-powered wireless condiiton diagnosis system

ing an autonomous diagnosis system for outdoor equipment with photovoltaic panels and wireless LAN devices and putting it into actual use (see **Photo 3**). The developed system is now under field tests with respect to the specifications of the power generation and consumption and the stability of wireless communication.

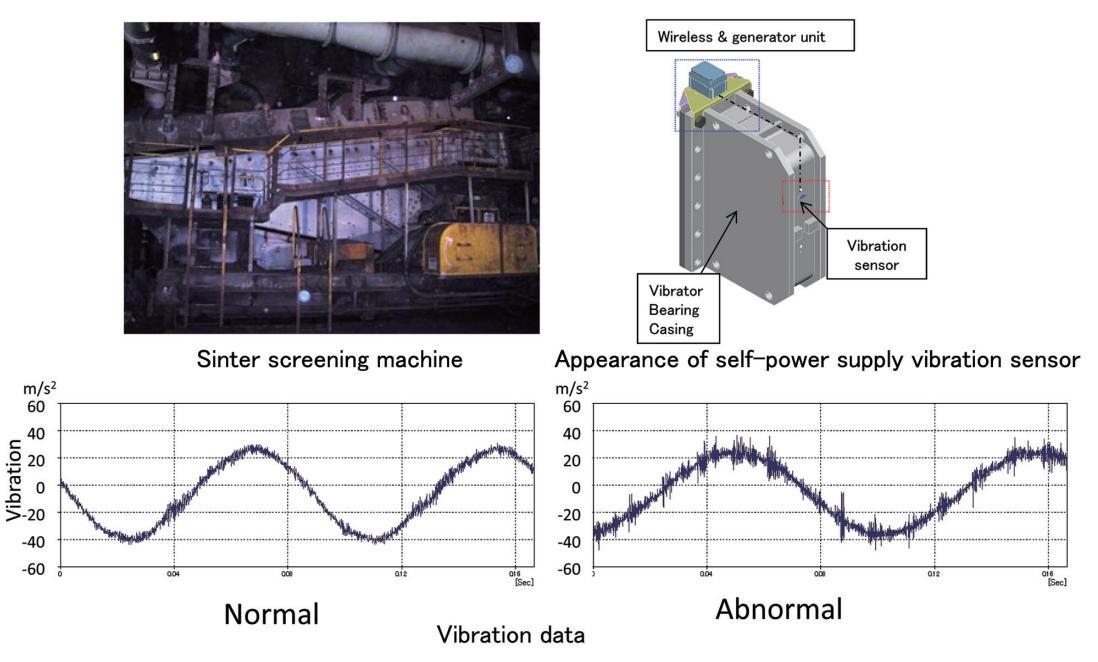
Fig. 15 Energy harvest wireless vibration sensor

cally usable vibration sensor that includes power generation and wireless data transmission. **Figure 15** shows one such example: a vibration diagnosis unit equipped with an exclusive power generator and a wireless transmitter is monitoring a bearing for the vibrating screen of a sintering machine. Since the transmitter is capable of sending unprocessed original vibration waves several kilo Hertz in frequency, precision analysis of the vibration condition is possible using a fixed system for frequency analysis after a preliminary alarm has been given from the local unit based on simplified trend analysis. This system is being refined to unify the sensor and the auxiliary units into one package and making the package as compact as possible.

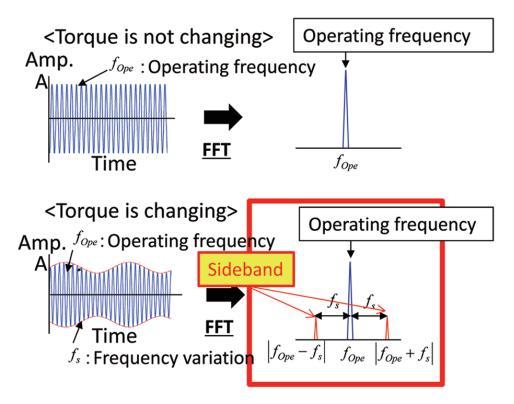
Fig. 17 Waveforms under torque variation

MCSA is considered promising for detecting secular damage of motor bearing and unbalance of shaft; detecting bearing misalignment is more important. When the mass distribution of a motor is circumferentially unbalanced about the shaft, the shaft turns in a waggling manner, and the torque fluctuates, which leads to fluctuation of the motor current, and by monitoring the current fluctuation in a low frequency band (roughly 100 Hz or below) it is possible to detect unbalance of the shaft. As seen in **Fig. 16**, with a common induction motor, change in torque leads to change in the slip and the current, ⁷⁾ which causes formation of side bands about the operating frequency as seen in **Fig. 17**. The advantage in monitoring the fre-

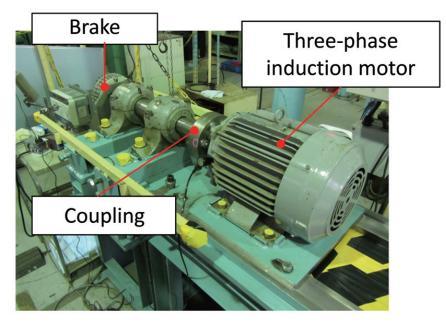
Fig. 18 Motor driven rotating simulator

The sensitivity at detecting motor shaft unbalance based on MCSA was tested using the motor-driven rotating simulator shown in **Fig. 18**. The FFT curves of the motor current at 200 and 800 rev/min are given in **Fig. 19**. At either revolution, difference in peak heights is clearly seen in the side bands on both sides of the operating frequency, which indicates that it is possible to detect shaft unbalance based on MCSA.

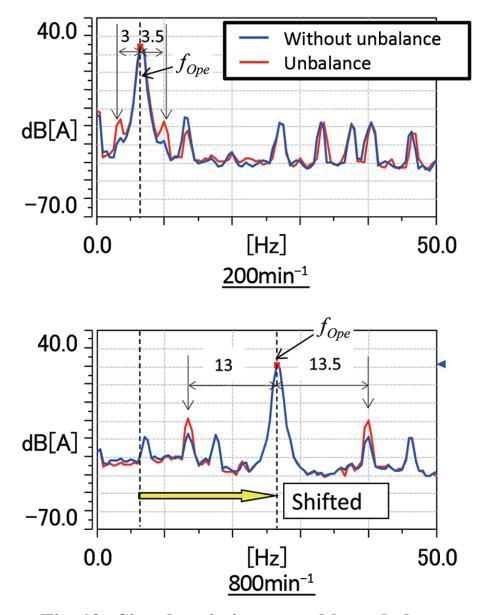
Fig. 19 Signal variation caused by unbalance

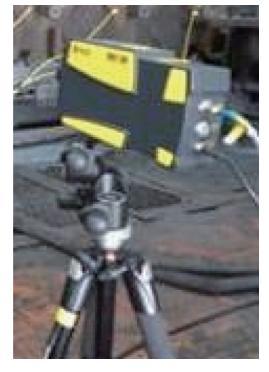
Photo 4 Portable laser Doppler vibrometer

a reference. **Photo 4** shows the tested LDV, and **Fig. 20** the object machine (a bearing housing) used for the test. In the first place, to confirm how the laser reflection changed depending on the object surface condition, laser reflection was measured at two areas of the object machine, one polished and the other not polished. **Figure 21** compares the readings of the vibration (acceleration) by the LDV from a distance of 5 m with those by the acceleration sensor. The S/ N ratio by the LDV is very similar to that by the common acceleration sensor in the frequency range of 4 kHz or below, especially 1.5 kHz or below, which corroborates the applicability of LDV for trend monitoring of the defects of shafts such as unbalance and misalignment and that of some gears.

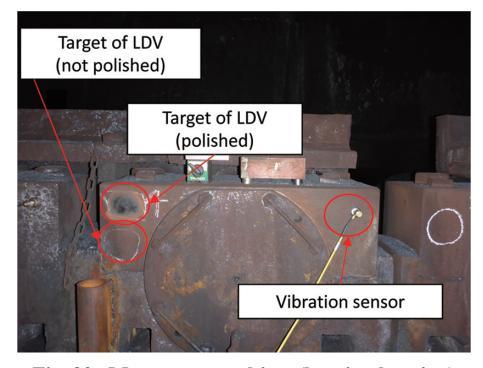
Fig. 20 Measurement object (bearing housing)

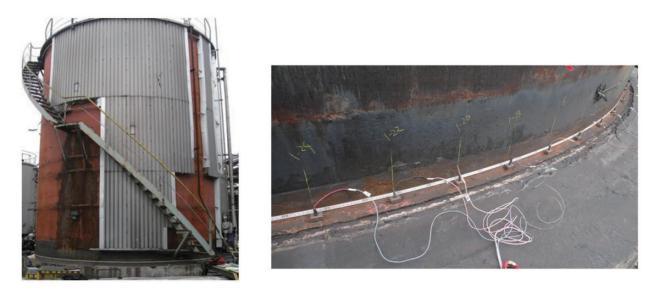
Photo 5 Inspected object and partial view of inspection by direct current potential different method

and finding thinning of tank bottom plates and other structural members that have broad surface areas and often covered with heat insulating materials. Since the method is applicable while an object equipment is in operation, such as the examination of a tank bottom in actual use from the periphery shown in **Photo 5**, overhaul is not required. As is seen in **Fig. 22**, comparative tests have confirmed that thickness distribution measurement of a steel plate by the method yields results similar to that by ultrasonic measurement. The company intends to further improve the method in terms of resolution, accuracy, and reliability.

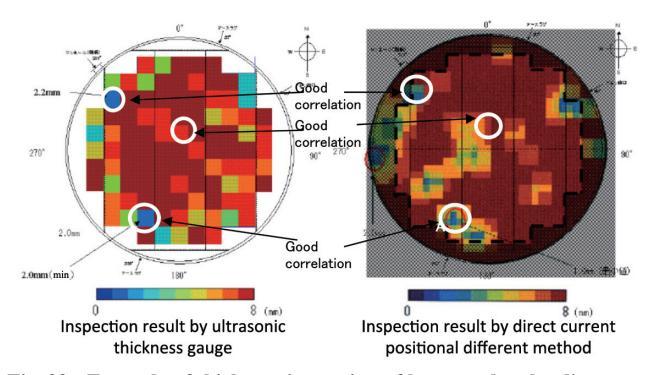
Fig. 22 Example of thickness inspection of bottom plate by direct current potential difference method

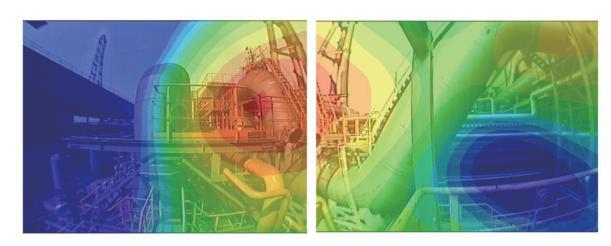
Fig. 23 Sound source investigation by sound visualizing system

Nippon Steel & Sumitomo Metal has been developing a method for identifying noise sources by visualizing possible sources in works areas using a sound source investigation device equipped with microphones and cameras. **Figure 23** shows an example of such investigation at an area near a dust collector of a steelmaking plant jumbled with pipes and ducts. This method employs the beam forming method, whereby sound waves from different sources are caught by two or more microphones and the direction of the source of a particular sound is identified relative to the device based on the time difference of its arrivals at different microphones. The direc-

By visualizing the sound of the noisiest frequency band as in Fig. 23, it is possible to pinpoint the sound source and take measures to suppress the noise.
