Technical Report

Advanced Anticorrosion Coating Technologies in Steelworks Maintenance

Abstract

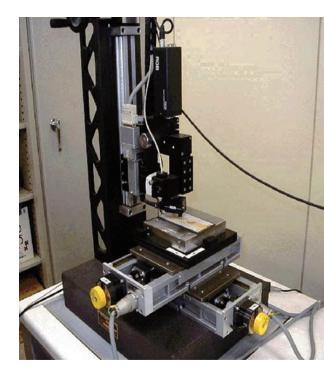
Photo 1 3D surface profiler

In the education of corrosion and anticorrosion technologies, in order to assist them understand the coating film deterioration phenomena, corrosion acceleration experiment on a coated test piece in a salt water spray test (termed as SST hereafter) was conducted and its three-dimensional surface configuration was mesured.²⁾ The measuring device shown in **Photo 1** is a laser range finder combined with an XY scanning table. **Figure 1** shows a result of measurement

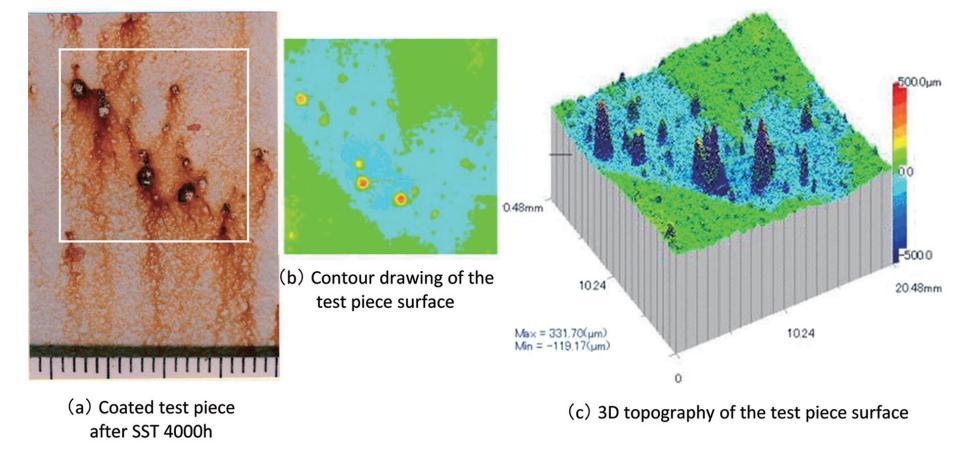
Fig. 1 Photo and 3D topography of a coated test specimen existing some blisters

using the device. Figure 1 (a) shows the measurable range of a test piece and, (b) and (c) show the contour drawing and the topography of the coating film surface obtained by the three-dimensional surface profiler. It is known that spot rust, which looks black in (a), is a blister having a height of several hundred μ m.

By this experiment, state of progress of coating film deterioration is clearly displayed, and it is understood that area-wise coverage ratio of generated rust (%) is the area-wise coverage ratio of blisters. It was shown that; based on this and by setting a threshold on the blister height and, by calculating the area corresponding to the height exceeding the threshold value in the three-dimensional surface configuration measurement device, area-wise coverage ratio of generated rust (%) can be calculated.²⁾ This method can be said to be an effective method to diagnose the coating film deterioration of a test piece on laboratory test base. However, it cannot help but stating that application of the three-dimensional surface configuration measurement to outdoor huge equipment coating film diagnosis is difficult, because of limitation of measurement range to about 20 mm square.

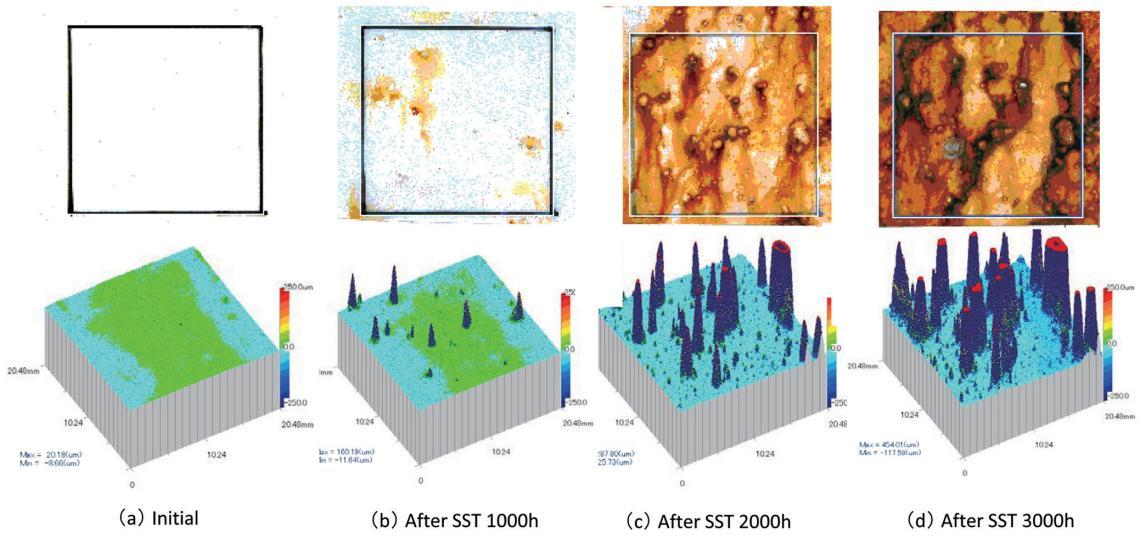
Fig. 2 Photos and 3D topographies of alkid paint 70 µm coating sample (initial and after SST 1000 h, 2000 h, and 3000 h)

In **Fig. 2**, state of growth of rust along the time in SST is shown by photos and three-dimensional topographies. From these results of

measurement, it is known that coating film deterioration phenomenon takes a process of developing blisters on a coating film surface that grow gradually, expand and yield rust flow from the tips of the blisters that stain the surrounding areas. As the coating film is separated from the steel surface inside the blister, coating film therein does not contribute to anticorrosion. Corrosion that grows inside of a blister is called sub-coating film corrosion wherein rust is generated, producing rust flow.

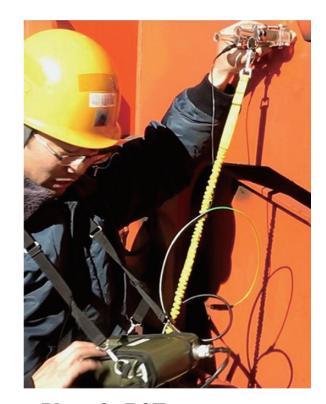
Photo 2 RST measurement

Photo 2 shows the actual practice of measuring coating film resistance using RST. **Figure 3** shows the sketch of the RST probe. Coating film resistance (R_R : called RST value hereafter) is shown in the equivalent circuit shown in **Fig. 4**. Principle of measurement is to let several mA alternating current of a certain frequency flow between two pistons filled with electrolytic solution and to calculate RST value (Ω). The RST value of anticorrosion coating film is higher than 20G Ω , exceeding the measurable maximum value, in a sound coating film condition immediately after coating, which will become several k Ω on the coating film where deterioration in coating film has developed and a number of blister have been generated.

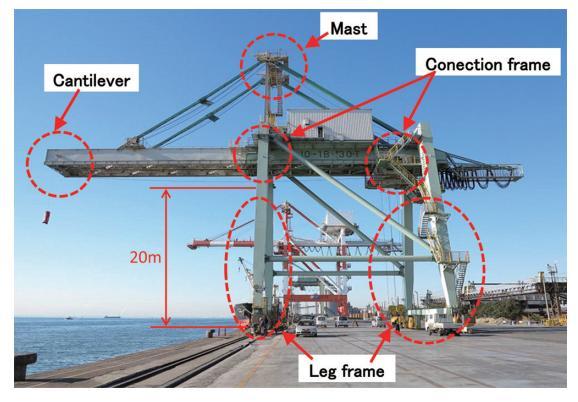
Photo 3 RST survey parts of a harbor loading crane

diagnosis for a harbor loading crane conducted in November of 2012 is explained. **Photo 3** shows the surveyed sections of a harbor loading crane in a steelworks. In **Table 1**, result of measurement at respective measured section and the photography of coating film

surface condition of the section are shown. RST value obtained on the actual equipment corresponds well to the state of deterioration judged through visual inspection and external view photos of coating film. Namely, RST values exceed $20 G\Omega$ at the upper back side section of the crane where salt of sea water splash adheres, however, easily washed away by rain fall. On the other hand however, the RST values were very low of about $20 k\Omega$ on the coating film on the inner side of the front end of the cantilever where the amount of adhering salt is large and the salt is not easily washed away by rain fall and, progress of corrosion was observed. As above, it is found that RST values are very useful for coating film diagnosis of practical equipment and quantitative maintenance data in a form of RST value is characteristically made available. Furthermore, it was confirmed that coating films on all parts of an equipment do not deteriorate evenly and equally. The coating films exposed to severe corrosive environment deteriorate antecedently. Therefore, some difference exists in the extent of deterioration in the whole equipment.

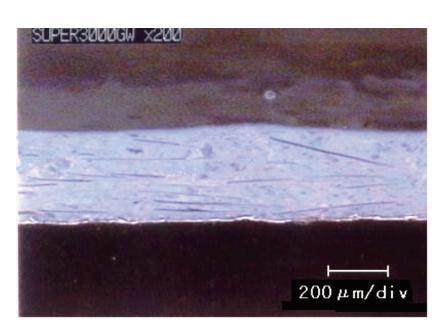
Photo 4 Cross-section of developed high-build paint

Outline of the improved thick film type modified epoxy resin paint^{8,9)} is stated hereunder. In order to enable thick coating of more than 100 μ m with one time brush painting, as **Photo 4** shows, the paint is designed to enable thick film coating by brush repainting in wet paint condition with addition of optimum amount of squamous pigment having a specific aspect ratio. **Photo 5** shows the comparison of anticorrosion performance of the one layered thick film coating film peeled off at the cross-cut section of the thick film coating after 2000 hours in SST is 2.5 mm, Photo 5 (a). It is confirmed that the thick film coating is highly excellent anticorrosion performance comparing with the Coating System A.

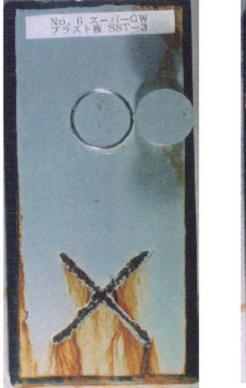
Photo 5 Anti-corrosion performance comparing developed high-build paint with alkid paint system (after SST 2000 h)

(a) Developed high-build paint 200 μ m (1 layer)

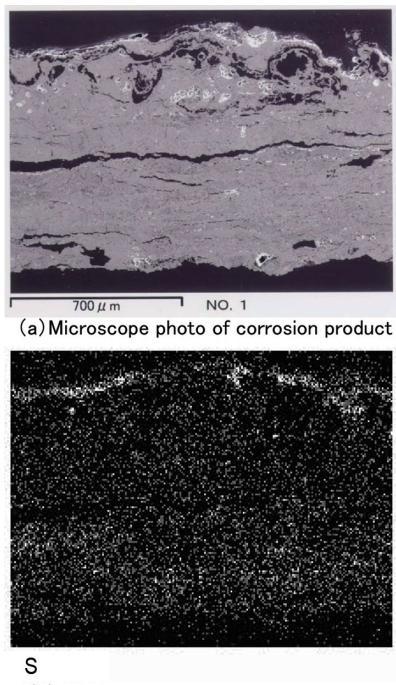
Photo 6 Photo and EPMA S distribution of corrosion product in COG pipe

(b) EPMA image of S distribution

However, on the inner surface of these pipe lines, corrosion is slowly developed by corrosiveness of gases and drain, and some problematic conditions like perforation or the like occurs after about thirty years operation.¹⁰ In case of COG pipe lines, such phenomenon has been confirmed with, for instance, laminar corrosion product as shown in **Photo 6** formed by the effect of hydrogen sulfide in COG and sulfite ion and the like in drain.¹⁰ Furthermore, in LDG pipe lines, corrosion is developed by carbon dioxide gas contained in a gas and or drain. For these reasons, anticorrosion technology that can control the internal corrosion of energy pipe lines has become necessary in steelworks.

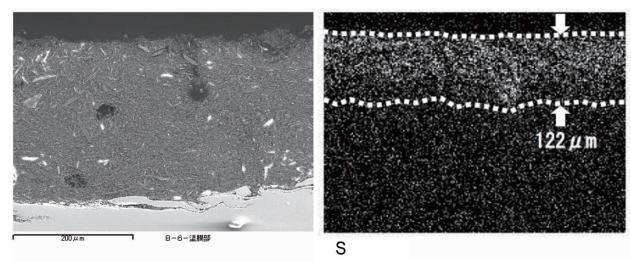
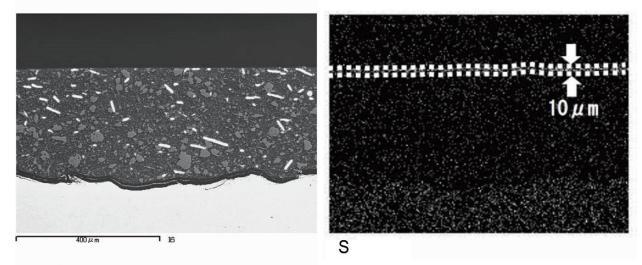
Photo 7 Cross-section of coating films after 6 months dipping test in COG drain

(a) Cross-section of solvent resin paint film (left photo) and S distribution (right photo)

(b)Cross-section of developed non-solvent epoxy resin paint film (left photo) and S distribution (right photo)

als contained in gases and drain (chemical resistance) and barrier properties against environment. Then, a non-solvent type epoxy resin paint that has a strong molecular structure, hardened at normal temperature and has high glass transition temperature (Tg), allowing easy handling on site was developed.^{10, 11)} In order to confirm the anticorrosion performance of the developed paint, some exposure tests for comparing its anticorrosion performance with those of various coatings have been conducted. In Photo 7, a result of analysis of coating film cross-section of a coated specimen after six month dipping test in drain in a COG pipe line is shown. When a solvent type chemical resistant paint and developed non-solvent type paint are compared based on the cross section photos and the results of observation of sulfur penetration distribution taken by an electron probe microanalyzer, it is found that the developed paint suppresses the penetration of sulfur from coating surface remarkably. Presently, the developed paint is employed as anticorrosion paint for inner surfaces of various energy pipe lines and steel smoke stacks. Photo 8 shows the actual internal coating work for COG pipe line. 3.3 Corrosion prevention of pipe supporter

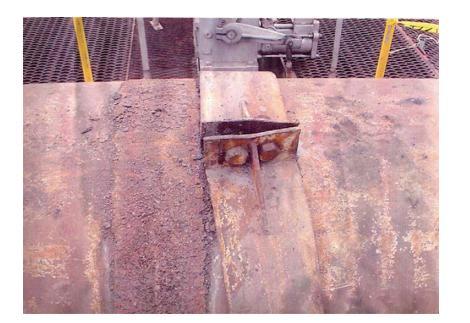
Photo 9 Crevice corrosion under pipe supporting bands

Photo 9 shows the rust grown on the pipe surface under the band at the crevice observed after the band is loosened. This phenomenon is considered to be attributed to the wet and hard-to-dry condition brought forth by the penetration of rain water. Ultimately it reaches perforation sometime and an anticorrosion measure is necessary when the situation cannot be ignored. As a method of anticorrosion measures, although a method of removing of the pipe from the pipe supporter and recoat the crevice section is conceivable, the method is impractical as; not only it requires big expense but also has a possibility of causing gas leakage at the time of removing the pipe and therefore the method cannot be implemented without shut down of the gas supply. In steelworks, which is operating around the clock, since even a temporal shut down of gas supply results in a great influence in the steel production schedule, a method of providing anticorrosion performance without removing the pipe from a pipe supporter was seriously required.

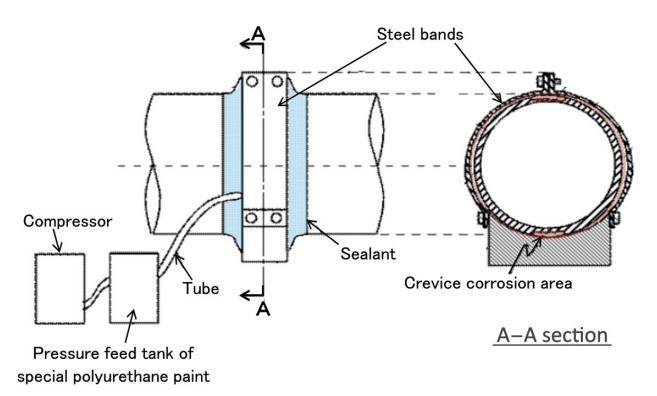
Fig. 6 Anti-corrosion coating into the gap under pipe supporter and bands

Then, a method of supplying anticorrosion performance to the pipe on the pipe supporter was developed. This is a method of pressing an easy-to-penetrate low-viscosity urethane resin paint into the crevice between the pipe and the pipe supporter or between the pipe and the steel band.¹²⁾ Figure 6 shows the outline of the method. Upon pressing the low-viscosity urethane resin paint, except the pressing-in section and the discharging section, the crevices between the pipe and the steel band edge and, the pipe supporter and the pipe are sealed and hardened so that the paint is penetrated into the entire crevice. The low-viscosity urethane resin paint has the characteristics of arresting water existing in the crevice during the process of

hardening after penetration. For this, water exiting inside the crevice is absorbed by the paint and made harmless, securing anticorrosion effect. Photo 10 shows the actual application work of the pipe supporter anticorrosion method.

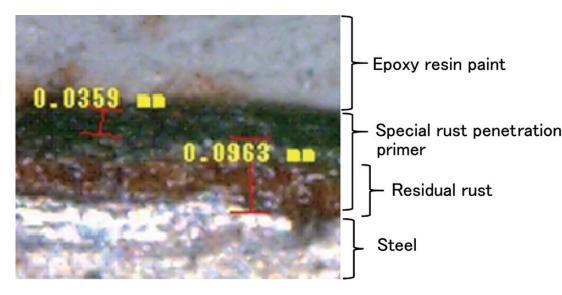
Photo 11 Cross-section of developed light tool cleaning coating

Light cleaning is defined as a rust removing work leaving a rust layer of about 100 μ m and as shown in Table 2, comparison tests of anticorrosion performance of coating up to SST 3000 hours were conducted. It is confirmed that; below 100 μ m of residual rust layer, anticorrosion performance up to 3000 hours can be secured with the coating of the special type primer paint having penetration ability to rust, further coated by normal thick film coating. As observed in Photo 11 showing the coating film section, the sufficient penetration of the special type primer into the thin rust layer of less than 100 μ m and suppressing effect to corrosion in residual rust are considered to be the major reason.

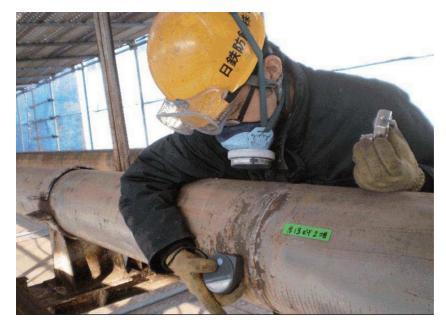
Photo 12 Rust thickness measurement in developed light tool cleaning coating

ing work as shown in **Photo 12**, the residual rust film thickness is checked during light tool cleaning to be maintained below $100 \,\mu\text{m}$. Furthermore as shown in **Photo 13**, there are cases of cleaning work in which water jet sand blasting is applied. This example shows the case of coating the external surface of a gas holder. Water jet sand blasting has been employed as a method that can clean a large area in a very effective way and inexpensively without dangerous possibility of igniting as the method does not cause sparks. However, since long term durability of the coating with light tool cleaning

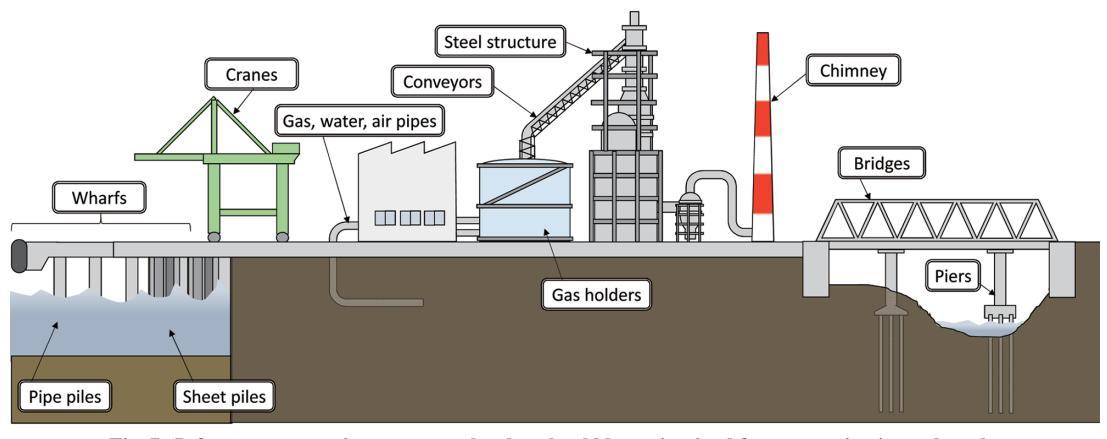
Fig. 7 Infrastracture-equipment examples that should be maintained from corrosion in steel works

As mentioned above, several coating film diagnosis technologies and anticorrosion coating technologies were introduced. However, as Fig. 7 shows, a large number of huge infrastructure equipment needing anticorrosion maintenance exist in steelworks, which imply unsolved and or unclarified problems or areas where application of developed technologies are expected. They are, for instance, corrosion under high temperature environment like inside of a smoke stack, corrosion prevention of equipment in marine environment and or in earth and, corrosion prevention and reinforcing of underwater concrete structures. Furthermore, establishment of a system that preserves record of inspection for projecting to equipment maintenance and managing plan is also required. As the above shows, corrosion prevention maintenance is the field wherein coordinated work of a number of divisions in vast technological arena is necessary with respective division fulfilling its own work and, incessant efforts must be maintained. Hereafter, Nippon Steel & Sumitomo Metal and Nippon Steel & Sumikin Anti-Corrosion Co., Ltd. continue to make efforts aiming at more securer and higher level anticorrosion maintenance in steelworks under the cooperation between divisions in charge and related companies.
