Technical Report

Improvement of Crashworthiness in Hat-shaped Components Made of High-strength Steel Sheet

Seiji FURUSAKO* Satoshi HIROSE Masanori YASUYAMA Masatoshi TOKUNAGA Shinji KODAMA

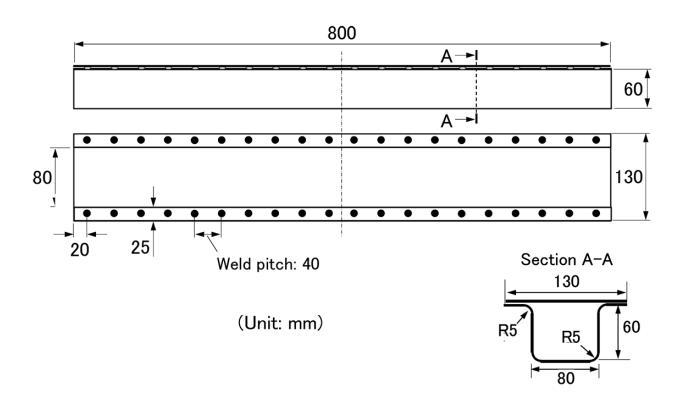
Fig. 1 Schematic of the hat-shaped component

The three-point bending test results were analyzed using NSafeTM-SPOT to obtain the load that acted on each welded area and the fracture risk rate caused by the load. The component shape and welding pitch were the same as that shown in Fig. 1. The nugget diameter of all welded points was determined to be $3\sqrt{t}$. The steel strength was at the 1470 MPa level, assuming the strength of 1470 MPa-class hot stamped steel (1.4 mm-thick) with a carbon content of approx. 0.2%. The constraints and boundary conditions for the components were defined such that the test in Fig. 2 was reproduced. The analysis result showed that the welded area in the center of the component crashing with the impactor was predicted to fracture due to shear force. In addition, the fracture was predicted to involve a sharp increase in peel force at the adjacent welded areas, resulting in fracture of the adjacent ones as well. From this result, it is considered that an increase of the nugget diameter would be effective for preventing fracture for welds in the center of the component. This is because an increase in the nugget diameter (joint surface area) is highly effective for improving the shear strength of a welded area. To prevent the fracture of adjacent welds, continuous joining

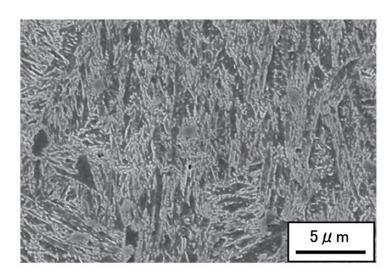
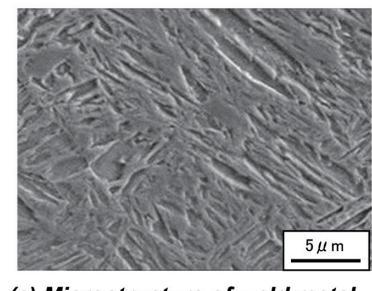
(b) Microstructure of base metal

(c) Microstructure of weld metal

Fig. 3 Cross-section and microstructure of resistance-spot-weld

Figure 3(a) shows an image of the cross-section of the spotwelded area with the $5.0\sqrt{t}$ - diameter nugget. The RS welded area was subject to the pressurization and heat input by electrode during welding, forming a concave cross-section. Figure 3(b)(c) show images of the structure of the base metal and weld metal (nugget). Tempered martensite was observed in the base metal. Such a structure was formed as a result of the above-described heat treatment

consisting of quenching and tempering. Although martensite was formed in the weld metal and adjacent heat affected zone (HAZ), almost no carbide was observed. This is because cooling speed at the welded area was high enough to prevent auto-tempering after quenching (tempering that occurs in the cooling process after quenching).

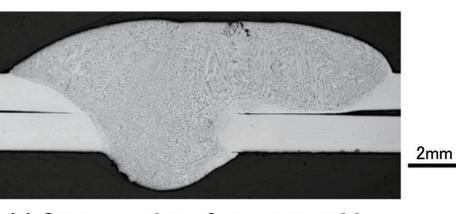
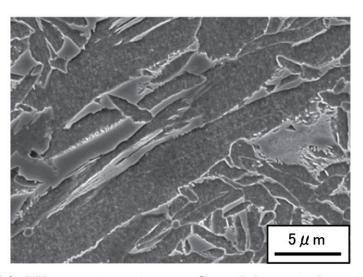
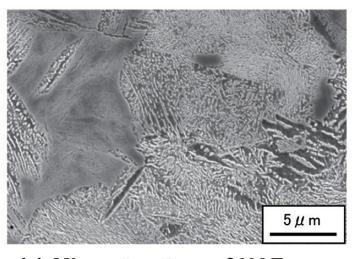
(a) Cross-section of arc spot weld

(b) Microstructure of weld metal

(c) Microstructure of HAZ

Fig. 4 Cross-section and microstructure of arc-spot-weld

Figure 4 shows images of the cross-section and structure of the AS welded area with the weld metal diameter of $5.3\sqrt{t}$. The AS welding constituted penetration welding unlike the RS welding, forming an excess metal on the front and back faces of the welded area. The main phase of the weld metal at the AS welded area was ferrite, with most of the remaining part occupied by pearlite. In the HAZ, ferrite and pearlite were observed in addition to martensite. The reason for structures differing in different areas in the AS welded area is mixing (dilution) of constituents of the base metal and the weld wire.

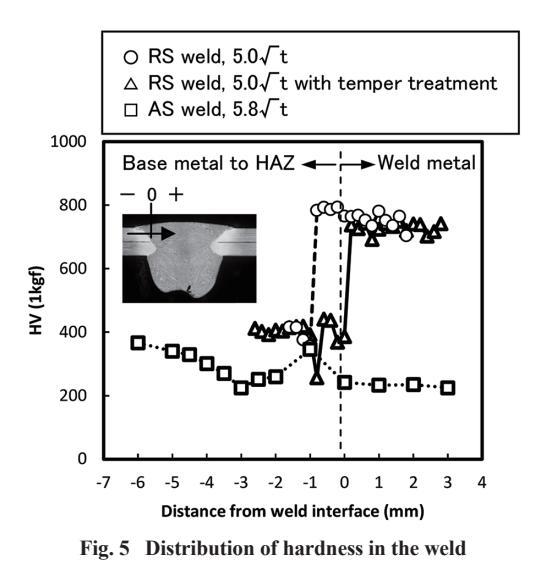
Figure 5 shows a chart plotting the comparison result of Vickers hardness distribution at the welded area between the two welding methods. The nugget Vickers hardness of the RS welded area reached HV 700. This value is equivalent to the martensite hardness estimated from the amount of carbon, and agrees with the structure observation result described above. At the RS welded area where current inputting for tempering was performed after the nugget formation, the hardness of the nugget edge and adjacent HAZ was reduced to HV 400. The reason for the softening was that martensite formed in these areas was tempered by current inputting for tempering.

The hardness of the weld metal at the AS welded area with the weld metal diameter of $5.8\sqrt{t}$ was HV 250, which was lower than the hardness obtained from the RS welded area. Similarly, the highest hardness of the HAZ was lower in the case of the AS welded area. As described above, this is because a comparatively soft structure was formed. At the area apart from the AS welded area and $5\sqrt{t}$ RS welded area, the so-called HAZ softened area in which the base metal was further tempered and softened was found. The width of this softened area was narrower than the RS welded area. The rea-

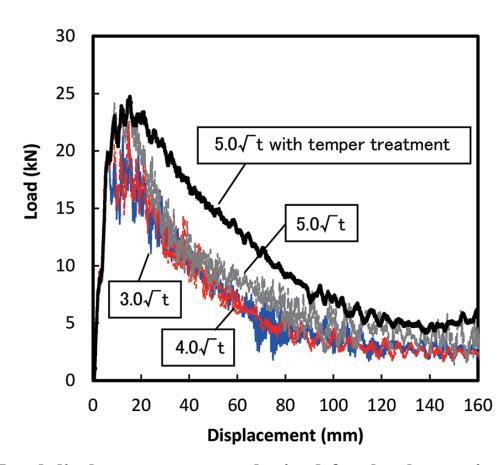
Fig. 6 Load-displacement curves obtained for the three-point bending test for spot-welded components

Figure 6 shows a chart plotting the relationship between displacement (component push-in quantity) of the impactor and the load obtained from the three-point bending test for the RS welded component. It shows that as the nugget diameter increased, the load level gradually increased, and that the load under the $5.0\sqrt{t}$ condition conducting current inputting for tempering was higher than the load under other conditions. As described later, the estimated causes for these results are: (1) The number of welded areas broken during the three-point bending test decreased due to an increase of the nugget diameter and the current inputting for tempering; (2) As a result, high rigidity of the component was maintained even if displacement was 20 mm or more.

When the nugget diameter was $5.0\sqrt{t}$, no cross-section collapse was observed in the hat shaped component with displacement of 15 mm or less. Fracturing of a welded area was found when the displacement was 20 mm. When the displacement was 40 mm, a collapse was observed in the hat shaped component cross-section. It appears that this cross-section collapse caused the decrease in the load on the component after the displacement reached 20 mm shown in Fig. 6.

occur during the test. The hat shaped component and the rectangle steel sheet were integrally deformed, while the two components suppressed the deformation of each other, keeping the rigidity of the components high. This is likely to be the reason for the load kept high during the bending test as shown in Fig. 6.

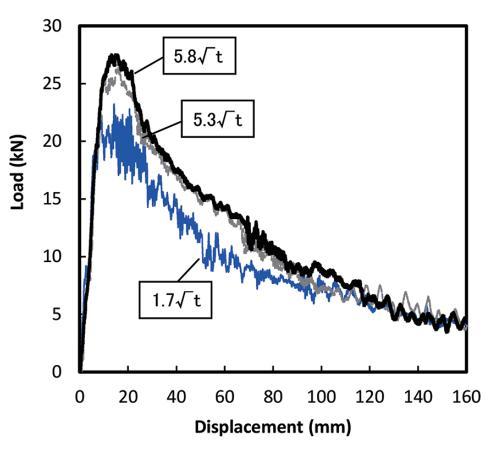
Fig. 7 Load-displacement curves obtained for the three-point bending test for arc-spot-welded components

Figure 7 shows a chart plotting the relationship between the displacement and the load obtained from the three-point bending test of the AS welded component. The load level increased along with the increase in the weld metal diameter. The reason for this is that similar to the case of the RS welded component, the number of broken welded areas decreased during the bending test along with the increase in the weld metal diameter, retaining the component rigidity.

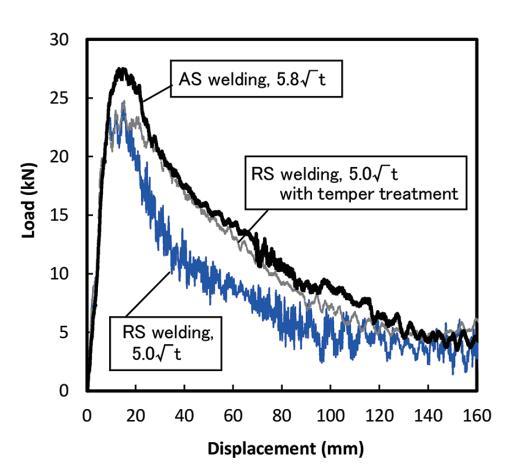
Fig. 8 Comparison of load-displacement curves obtained in the threepoint bending test between the resistance-spot-welded- and arcspot-welded-components

Next, the crashworthiness was compared between the RS welded component and AS weld component. From all the test conditions, we selected some conditions with the most excellent crashworthiness for comparison. Specifically, for the RS welding, we selected the conditions of the nugget diameter of $5.0\sqrt{t}$ and current inputting for tempering when the diameter was $5.0\sqrt{t}$; For the AS welding, we selected the condition of weld metal diameter of $5.8\sqrt{t}$. Figure 8 shows a chart plotting the relationship between the displacement and the load under the selected conditions. The figure explains that the load on the AS welded component was higher in the entire displacement range than the load on the RS welded component with the nugget diameter of $5.0\sqrt{t}$. It also explains that the load on the AS welded component was higher by the displacement range of 25 mm or less than the load on the RS welded component current inputting for tempering when the diameter was $5.0\sqrt{t}$.

As shown in Fig. 8, in the vicinity (15 mm) of the displacement, the load of the AS welded component with the weld metal diameter of $5.8\sqrt{t}$ was higher than the value of the RS welded component that underwent the current inputting for tempering with the nugget diameter of $5.0\sqrt{t}$. It is likely that this high load on the AS weld component was caused by "the delay in cross-section collapse" of the AS welded component in comparison with the RS welded component. However, as shown in Fig. 8, the loads of these components were generally equivalent to the displacement of 25 mm or more. Therefore, we think that after the collapse of the component rigidity became equivalent).

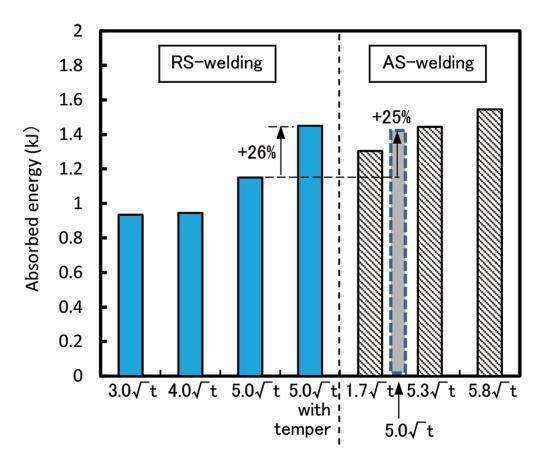
Fig. 9 Comparison of average absorbed energy between resistancespot-welded- and arc-spot-welded-components

The absorbed energy (AE) was defined using the load integrated by the displacement in the range from 0 to 100 mm. **Figure 9** shows a bar chart comparing the AE (average of the two samples) under all conditions. The figure shows that the AE of both welded components increased along with the increase in the weld diameter. Also, the AE of the RS welded component with the nugget diameter of $5.0\sqrt{t}$ improved by 26% as a result of current inputting for tempering. When compared under the conditions with the weld metal diameter of $5.0\sqrt{t}$, the AE of the AS welded component was higher by 25% than the value of the RS welded component that did not undergo the current inputting for tempering when the weld metal diameter was $5.0\sqrt{t}$. Assuming that the AE had linear relations with the weld metal diameter, the AE of the AS weld component with the weld metal diameter of $5.0\sqrt{t}$ was obtained using the AE when the weld metal diameter was $1.7\sqrt{t}$ and $5.3\sqrt{t}$.

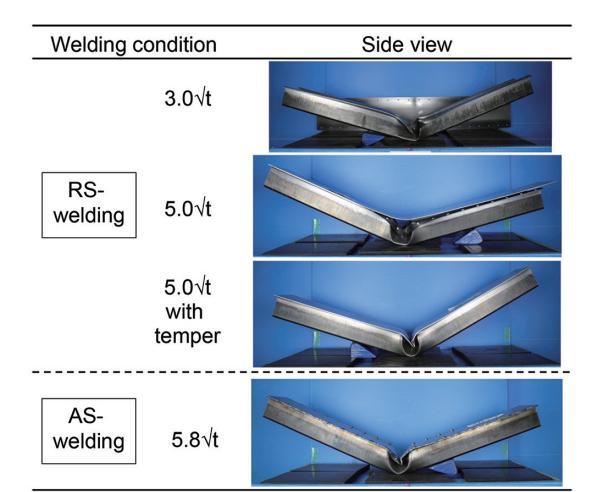
Fig. 10 Appearance of the components after the three-point bending tests

Figure 10 shows images of the appearance of components under several conditions taken after the three-point bending tests. In the case of the RS welded component with the nugget diameter of $3.0\sqrt{t}$, all welds were broken and separated during the bending tests. When the nugget diameter was increased to $5.0\sqrt{t}$, the number of broken welded areas decreased. When the current inputting

for tempering was additionally performed, the fracturing at welds was suppressed. When the weld metal diameter of the AS welded component was grown to $5.8\sqrt{t}$, the fracturing of welds was suppressed as well.

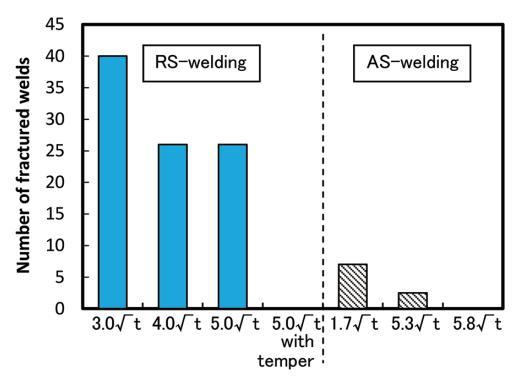
Fig. 11 Number of fractured welds of each component during the three-point bending test

Figure 11 shows a chart that compares the number of broken welded areas (average of the two samples) between the RS welding and AS welding under all conditions in the three-point bending test. Welded areas that were separated into two parts were counted as the "broken welded areas." The figure shows that the number of broken welds decreased in the AS welded component along with the increase of the weld metal diameter. For the AS welding, even with the weld metal diameter of $1.7\sqrt{t}$, the number of broken welded areas was 6. In view of the fact that all welds of the RS welded component with the nugget diameter of $3.0\sqrt{t}$ were broken, the AS welded areas were better in strength and (or) toughness than the RS welded areas. This tendency was reinforced by the result in which the cross tensile strength of the AS welded joint was higher than that of the RS welded joint.⁵

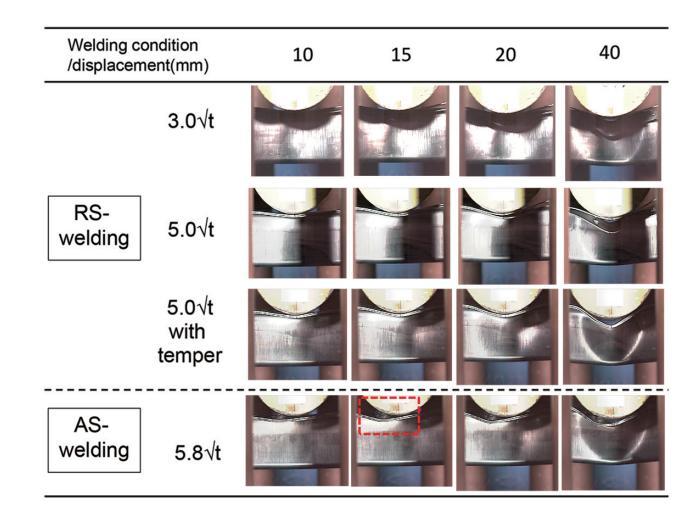
Fig. 12 Crash behavior around the center of the components during the three-point bending test

Figure 12 shows images of the crushing behavior of the components taken while undergoing the three-point bending tests. From all conditions, the images of the RS welded areas are those under the conditions of the nugget diameter of $3.0\sqrt{t}$, $5.0\sqrt{t}$, and the current

inputting for tempering with the nugget diameter of $5.0\sqrt{t}$. The images of the AS welded areas are those under the condition of the weld metal diameter of $5.8\sqrt{t}$. In the images, the longitudinal center of the component, i.e., the parts that crashed into the impactor are enlarged. For the RS welded component with the nugget diameter of $3.0\sqrt{t}$, the welded area was broken when the displacement was approx. 10 mm. At the same time, "distortion" (deformation involving falling inward) was observed on the wall of the hat shaped component. These fractures of welded areas were likely to have been caused by an increase in the load acting on the welded areas along with the deformation of the hat shaped component. The load level is considered to have decreased as shown in Fig. 6 as a result of the acceleration in the deformation of the component vertical wall after the displacement exceeded 10 mm.

Looking at the images of the crushing behavior of the AS welded component with the weld metal diameter of $5.8\sqrt{t}$ in Fig. 12, the welded area under this condition was not broken during the bending test. The images show that when the displacement was 10 mm, the excess metal of the weld metal located 20 mm to the left from the component center crashed into the impactor in the position indicated with a broken line rectangle. In other words, the impactor contacted at least two locations: the excess metal and component center. We think that the area that bore the stress increased in the component through such a contact status with the impactor different from the contact statuses under other conditions, suppressing the initial cross-section collapse.

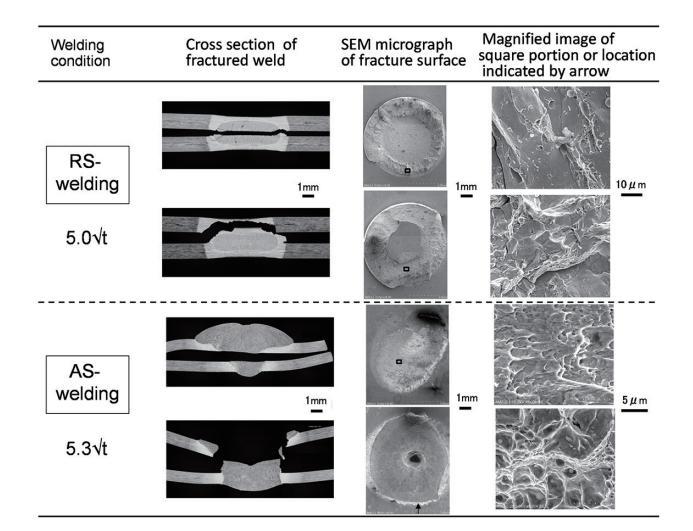
Fig. 13 Cross-sections and SEM micrographs of fractured welds during the three-point bending test

Figure 13 shows images of the welded area cross-sections of the RS welded component with the nugget diameter of $5.0\sqrt{t}$ and the AS welded component with the weld metal diameter of $5.3\sqrt{t}$ broken in the bending test. In the case of the RS welded component, fracturing at the welded area progressed either in the direction of the interface between the two steel sheets or in the thickness direction. The two fracturing directions were found from the AS welded component as well. Before the cross-section observation, the weld fracture cross-section observation was conducted using a scanning electron microscope (SEM). Figure 13 shows fracture cross-section images as well. At the RS welded area broken at the interface between

two steel sheets, an intergranular fracture surface was observed. Considering the size for each fracture, it appears that the grain boundary of dendrite was exposed on the fracture surface. In the case of the RS welded area broken in the thickness direction, we think that the former austenite grain boundary in the HAZ was exposed on the fracture surface.

Figure 13 shows images of the fracture surface of the AS weld component taken using SEM as well. Even after the welded area was broken at the interface between the two steel sheets, the fracture surface was in the shape of inclined dimples. This implies that the welded area underwent shear fracturing.

Dimples were also observed on the fracture surface of the weld broken in the thickness direction. As described above, an obvious difference was found on the fracture surfaces of the RS welded area and the AS welded area. This fracture surface difference as well indicates that the AS welded area exceeded the RS welded area in terms of toughness. Based on such superiority of the AS welded area, the crashworthiness of the AS weld component is better than that of the RS weld component.

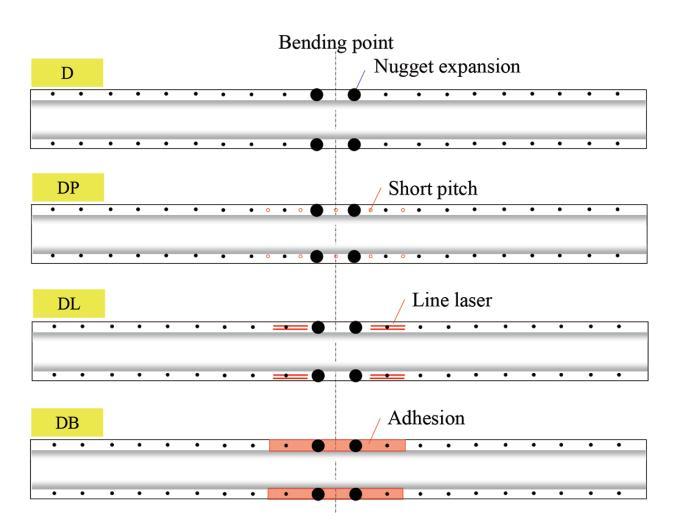
Fig. 14 Schematic diagram of components with weld-fracture-countermeasures

Figure 14 shows a schematic view of the specific measures. The measures are: Condition D involving an increase of the nugget diameter in the center of the component (an increase to $6\sqrt{t}$); condition DP involving an increase of the nugget diameter + an increase of welding points; condition DL involving an increase of the nugget diameter + laser beam welding; and condition DB involving an increase of nugget diameter + a structural adhesive. Figure 15 shows a bar chart plotting the verification results of the effects of these measures. The figure shows that the absorption energy with any measure was higher than the absorption energy under the comparative condition ($3\sqrt{t}$ for all) with no measure.

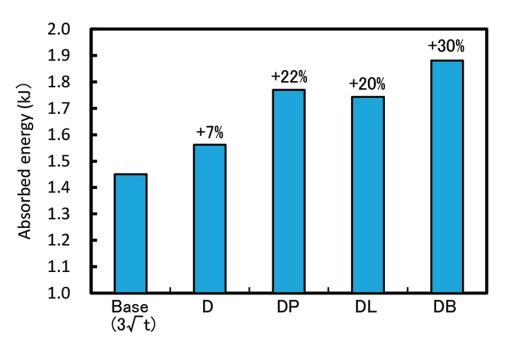
Fig. 15 Absorbed energy of component with each weld-fracture-countermeasures at 100 mm stroke

The AE improvement was 7% for D, around 20% for DP and DL, and 30% for DB. This indicates that any combination of an increase of the nugget diameter of the center welded area plus a reinforcement of the adjacent welded area was excellent in the improvement of AE. As shown in **Fig. 16** with images of the appearance of components after the test, D failed to prevent welded area fracture. It is likely that the center welded area and welded areas located on the side external to the center fractured caused by the fracture of an adjacent weld. Under DP, DL, and DB, by almost completely preventing fracturing in the center and neighboring welds where the acting load was high, the fracture of welds located external to them was able to be suppressed, showing high crashworthiness. Furthermore, it is considered that since the deformation restraint effect was

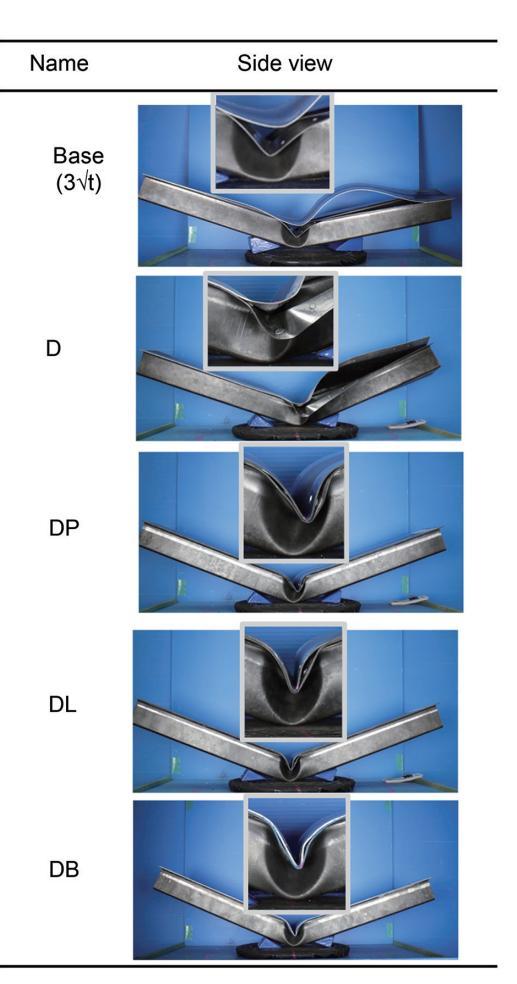
Fig. 16 Appearance of the components with weld-fracture-countermeasures after the three-point bending test

added by surface bonding, the maximum AE was shown under DB.
