# Introduction of Imported Silica Brick to Hot-blast Stove Refractory in Kashima No.1 Blast Furnace

# Abstract

# NIPPON STEEL TECHNICAL REPORT No. 125 DECEMBER 2020

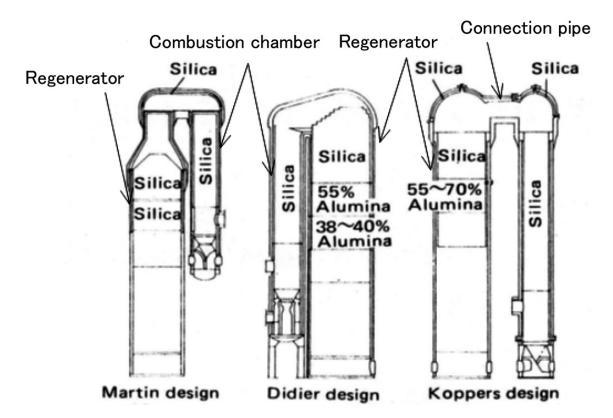
Figure 1 shows examples of refractory arrangement in three different types of external combustion hot-blast stove checker chamber.<sup>1)</sup> Each type uses silica bricks in the combustion chamber heated by the hot blast, in the pipe to connect the combustion chamber and checker chamber, and in the upper part of the checker chamber. Silica bricks are frequently used also in coke ovens. Since the temperature of the hot-blast stoves where silica bricks are used exceeds 1400°C, these silica bricks must have better creep resistance than those used in the coke ovens. For this reason, the silica bricks used in the hot-blast stoves have a higher SiO<sub>2</sub> content and a smaller amount of the liquid phase to cause creep than those used in the coke ovens.

Fig. 1 Refractories of various hot-blast stoves with external combustion chamber<sup>1)</sup>

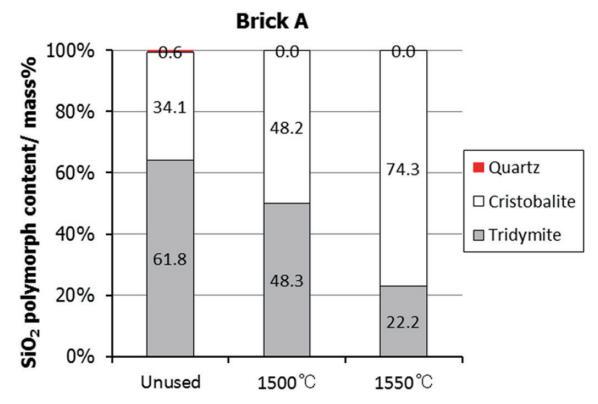
Fig. 2 Alteration of silica polymorph contents of brick A by creep test

We investigated the causes as to why the silica bricks expanded after the compressive creep test. **Figures 2, 3, 4,** and **5** show the measured silica polymorph contents of the respective silica bricks before and after the test. The silica bricks differed in the silica polymorph contents after the test and in the polymorph transition behavior. The C and D silica bricks are almost the same in the tridymite and cristobalite contents before and after the 1500°C compressive creep test. The A and B silica bricks progressed in the transition from tridymite to cristobalite and increased in the cristobalite content after the 1500°C compressive creep test. All silica bricks increased in the cristobalite content after the 1550°C compressive creep test. This increase was about 10 mass% in the C silica bricks and 24 to 26 mass% in the A and B silica bricks. In the D silica bricks, the transition to cristobalite remarkably progressed and about 94 mass% of silica transitioned to cristobalite.

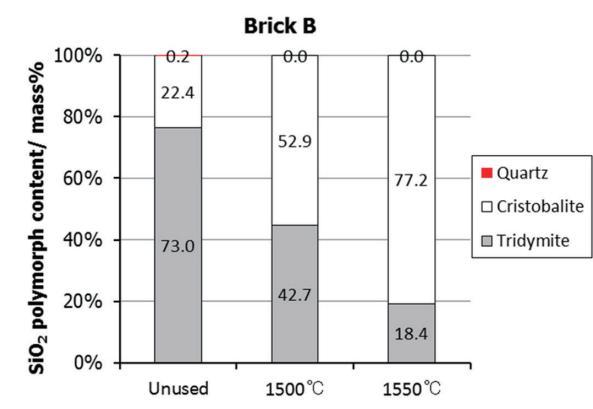
Fig. 3 Alteration of silica polymorph contents of brick B by creep test

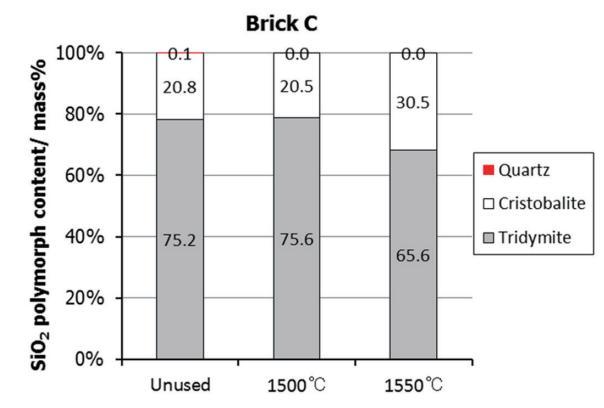
Fig. 4 Alteration of silica polymorph contents of brick C by creep test

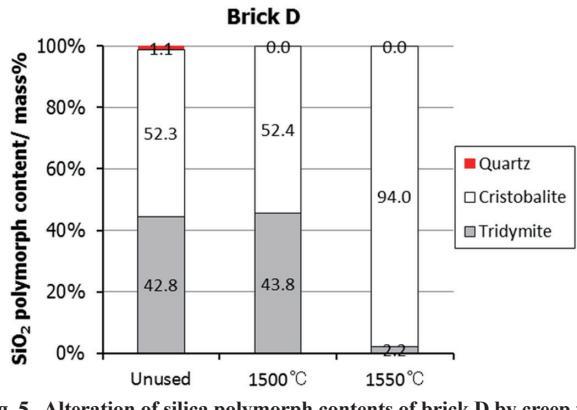
Fig. 5 Alteration of silica polymorph contents of brick D by creep test

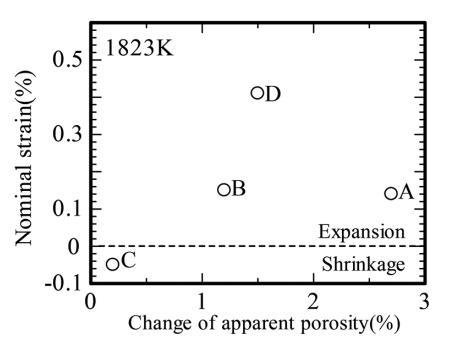
Fig. 6 Relationship between nominal strain and change of apparent porosity of trial bricks

**Figure 6** shows the relationship between the strain and the change in the apparent porosity after the 1550°C compressive creep test. The change in the apparent porosity is expressed in percent difference in the apparent porosity before and after the test. The strain and the change in the apparent porosity showed a nearly positive correlation. The expanded A, B, and D bricks increased in the apparent porosity. The non-expanded C bricks did not appreciably change in the apparent porosity. Also considering the measured silica polymorph contents before and after the compressive creep test, we considered that the bricks expanded in the test because the transition from tridymite to cristobalite progressed and created voids during the test.

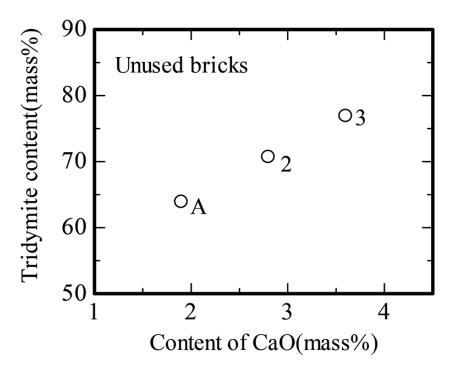
Fig. 7 Relationship between CaO addition and tridymite content of trial bricks

Table 4 shows the bulk density, apparent porosity, and chemical composition of the two types of trial silica bricks. The No.2 and No.3 trial silica bricks increased in the CaO content by 0.9 and 1.7 mass%, respectively, with respect to the base silica bricks. The trial silica bricks showed no significant changes in the bulk density and apparent porosity. Figure 7 shows the relationship between the CaO addition content and the tridymite content for the A silica bricks and the No.2 and No.3 trial silica bricks. The tridymite content increased by increasing the CaO addition content. The tridymite content of the No.2 trial silica bricks with a CaO addition of 2.8% exceeded that of the conventional silica bricks in Table 2. The tridymite formation increased by increasing the CaO addition probably

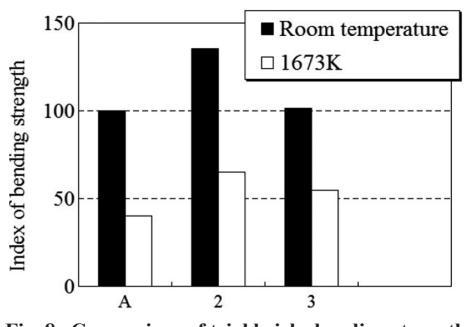
Fig. 8 Comparison of trial bricks bending strength

Figure 8 shows the measured 1400°C hot bending strength of the A silica bricks and the No.2 and No.3 trial silica bricks. In Fig. 8, the room-temperature bending strength of the A silica bricks is set to 100 and the bending strength of the No.2 and No.3 trial silica bricks is shown as the ratio to that value. The hot bending strength of all silica bricks decreased to about 50% of the room-temperature bending strength. The hot bending strength was not observed to decrease by increasing the CaO addition content. The hot bending strength was highest for the No.2 trial silica bricks with the CaO addition content of 2.8 mass%. The hot bending strength of the No.3 trial silica bricks with the CaO addition content of 3.6 mass% was lower than that for the No.2 trial silica bricks. Next, we conducted the compressive creep test of the trial silica bricks and investigated the strain at 1500°C and 1550°C and the silica polymorph contents before and after the test. Table 5 shows the strain of the No.2 and No.3 trial silica bricks after the test. Table 5 also shows the strain of the A silica bricks shown in Table 3 for comparison. The No.3 trial silica bricks exhibited expansion at 1500°C and 1550°C. The No.2 trial silica bricks exhibited little change in the strain at 1500°C and 1550°C.

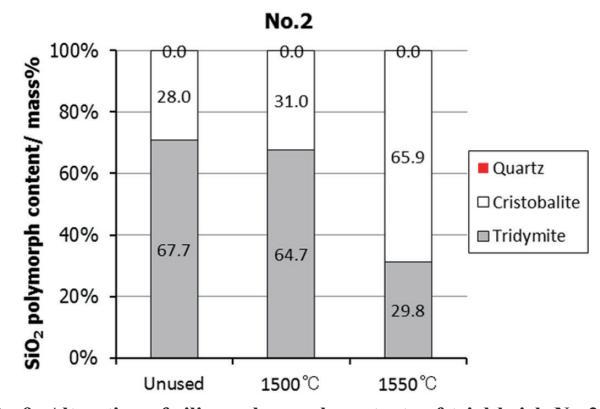
Fig. 9 Alteration of silica polymorph contents of trial brick No.2 by creep test

The measured silica polymorph contents of the No.2 and No.3 trial silica bricks before and after the compressive creep test are shown in Figs. 9 and 10, respectively. In the A silica bricks, the transition of tridymite to cristobalite progressed even at 1500°C and the tridymite content decreased to about 20% at 1 550°C. In the trial silica bricks, the transition of tridymite to cristobalite was suppressed at both 1500°C and 1550°C. The tridymite content at 1550°C increased to about 30% for the No.2 trial silica bricks and to about 40% for the No.3 trial silica bricks. As compared with the base A silica bricks, the increase in the tridymite content was larger for the No.3 trial silica bricks with the 3.6 mass% CaO addition than for the No.2 trial silica bricks. The No.2 trial silica bricks had a higher hot bending strength and a smaller strain change in the compressive creep test. According to these results, we decided to adopt the No.2 trial silica bricks as improvement on the A silica bricks and for use in the remaining one hot-blast stove. The three hot-blast stoves built of the improved silica bricks have been operating without problems for 15 years. The improved silica bricks are also used in the hotblast stoves of the Wakayama No.1 and No.2 blast furnaces that later came into operation.

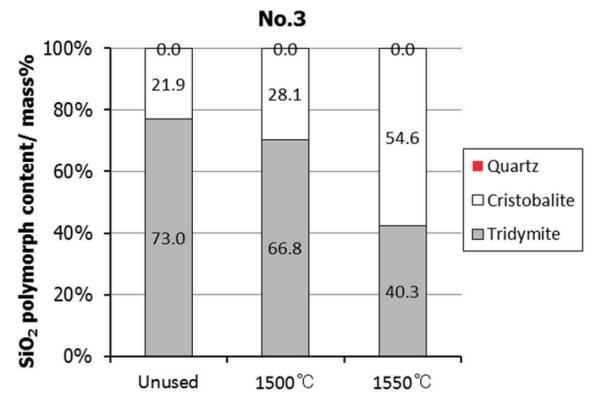
Fig. 10 Alteration of silica polymorph contents of trial brick No.3 by creep test
